# 1. Introduction

Tempered glass shower screens were introduced in Housing & Development Board (HDB) premium flats in 1999. Since then, 18,000 premium flats has been installed with tempered shower screen of which 14,000 flats completed installation and 4,000 flats are under construction.

# 5. Tempered Glass Breakage Investigation

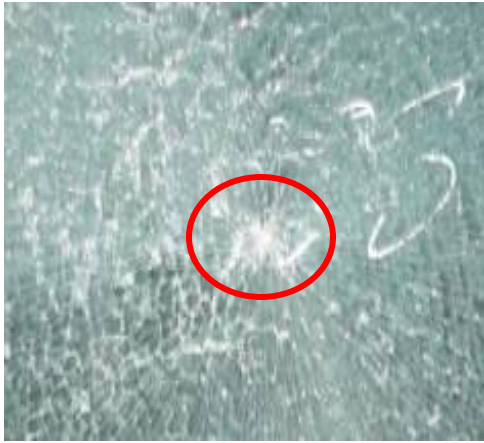
**glass panel; glass is chipped at the crack initiating point.**

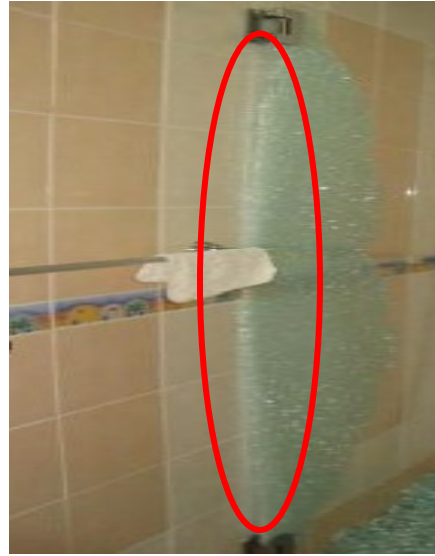
**glass panel; has concave**

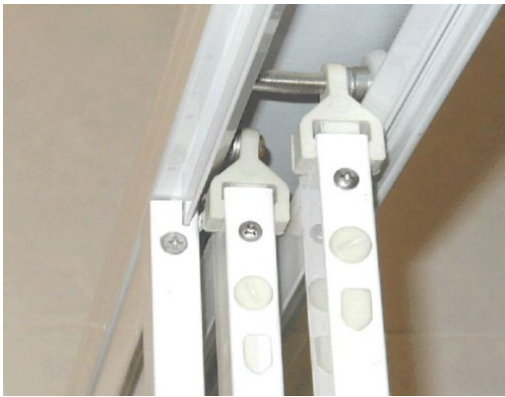
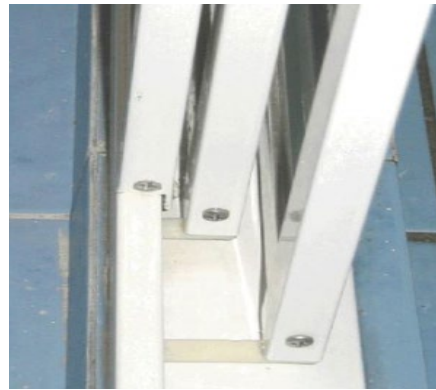
**hanging rollers and/or sliding guide; has dislodged, damaged or missing.**

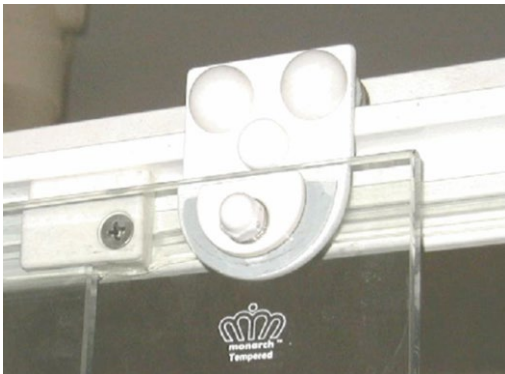
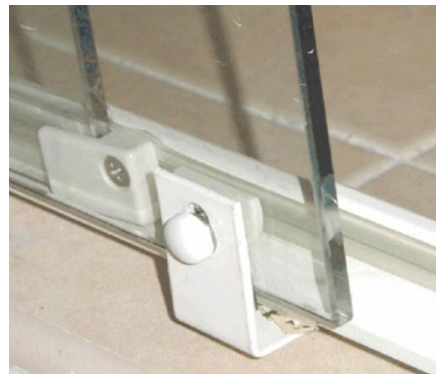
**hanging rollers and/or sliding guide; has dislodged, damaged or missing.**

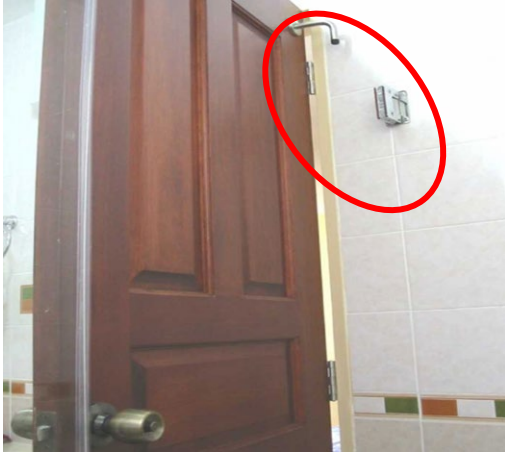
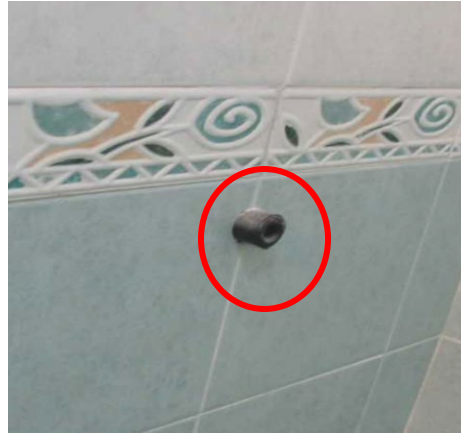
**door stopper, flipper weather strip; are missing, damaged or dislodged**

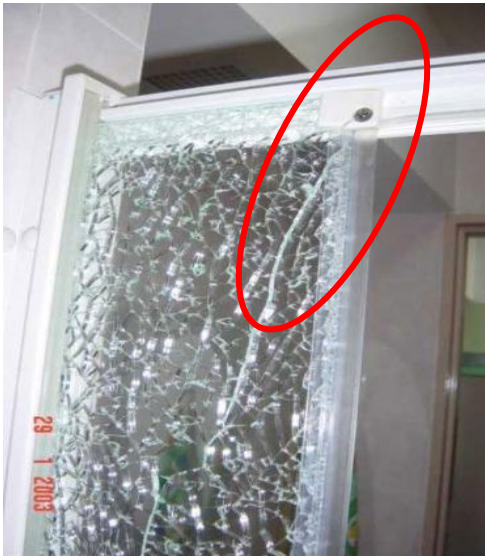
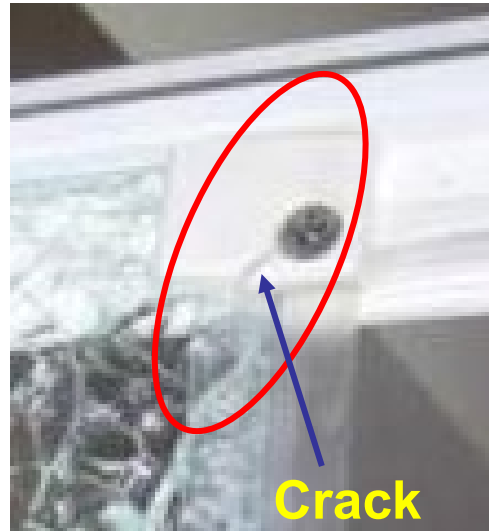
**brackets; has cracked, dislodged or missing.**

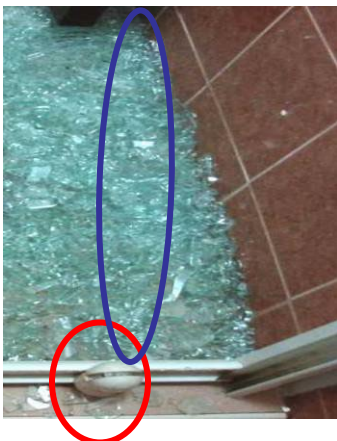
**door hinges; the pivot is in 'close' position but the door panel debris indicates it was open during the incident.**

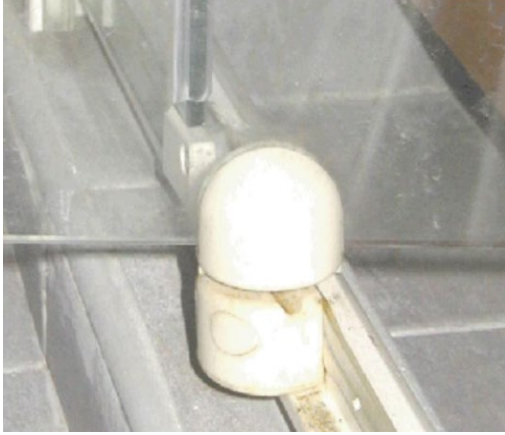
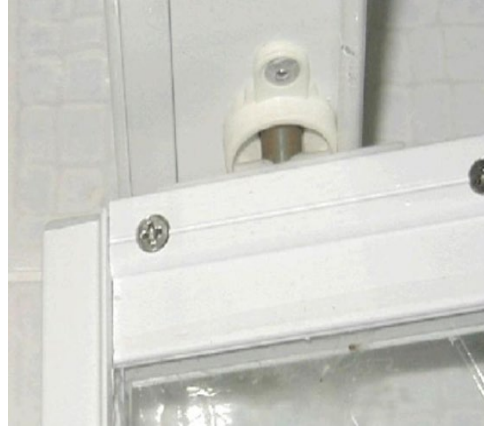
**Pivot hinges; has cracked or dislodged.**

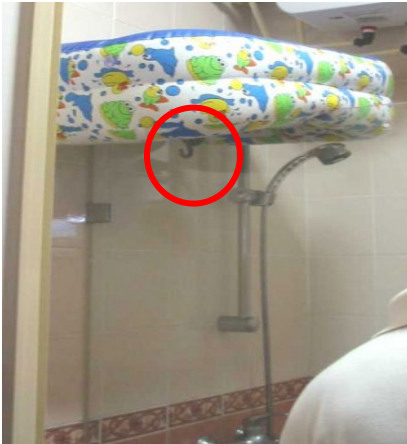
**foreign objects; with the means to cause damage.**

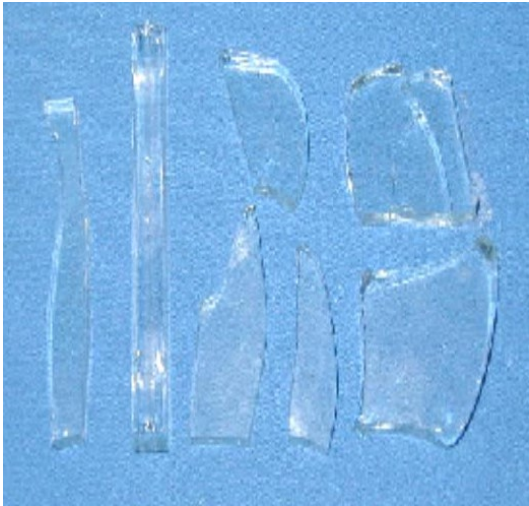
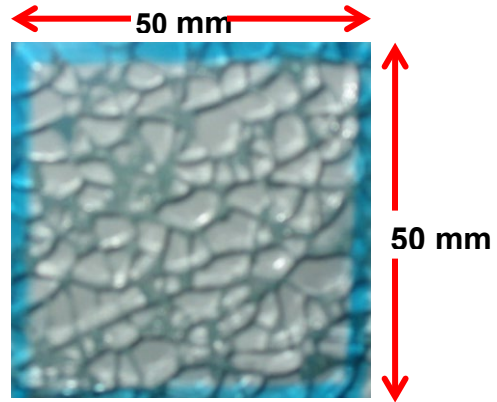
glass panel; large and shard-like glass fragment were presence.

≥ 30 pieces for 4mm thick glass panel

≥ 40 pieces for above 4mm thick glass panel

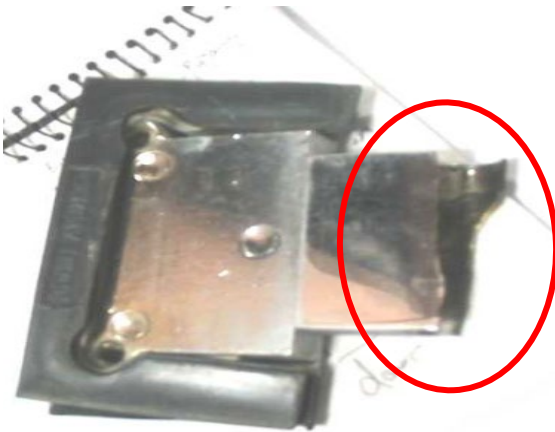
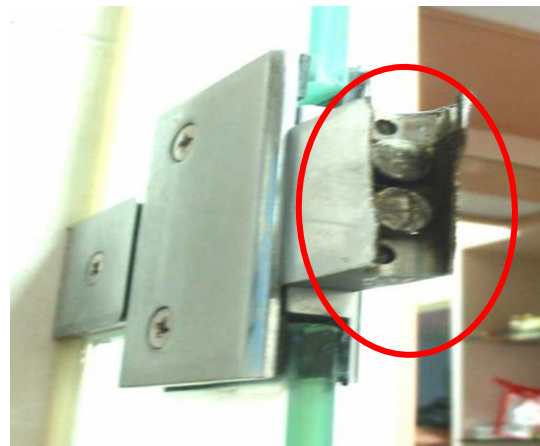
door hinges; stainless steel casing has cracked apart.

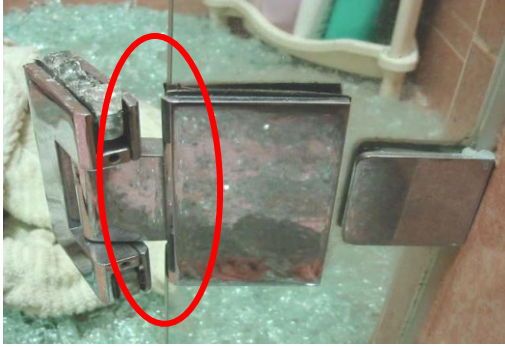
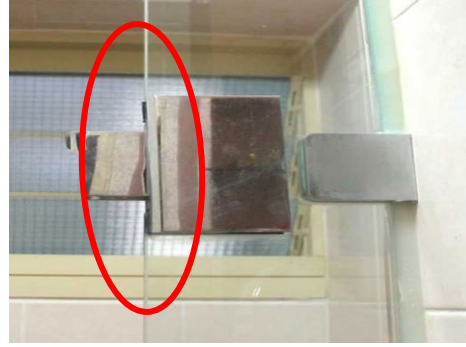
**door hinges; the pair were not in alignment with each other.**

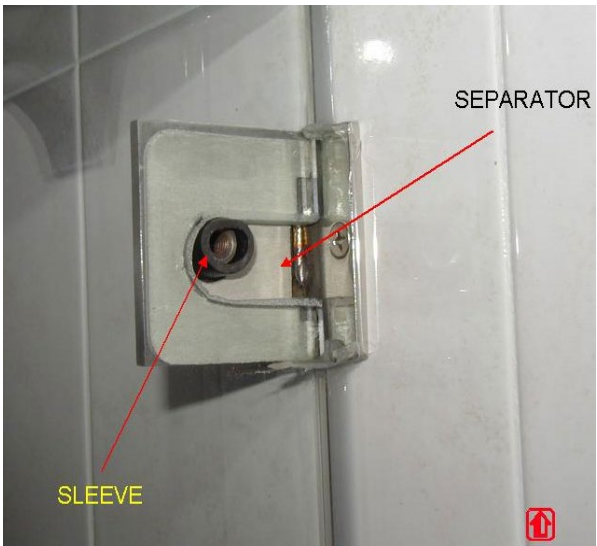
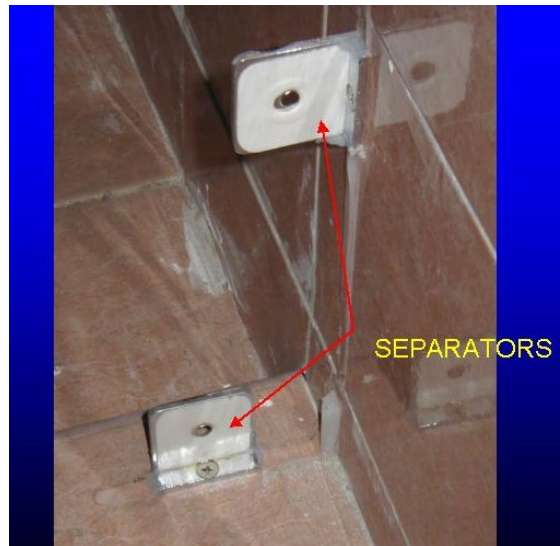
**separator between glass and metal parts; missing or out of position.**

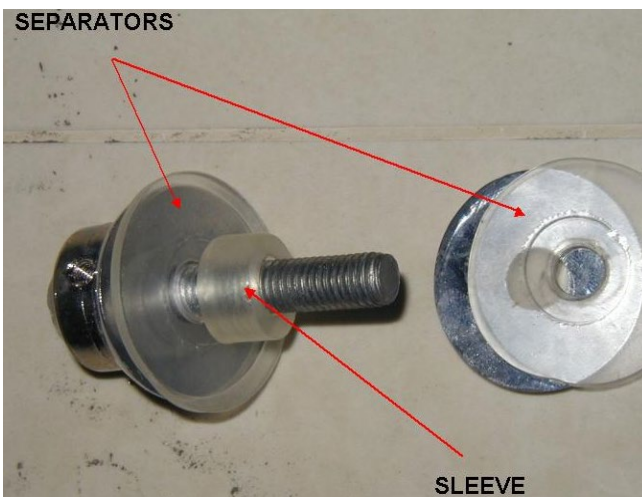
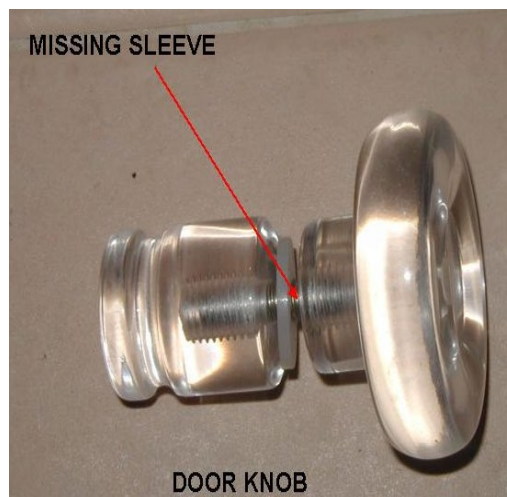
**insulating sleeve around openings; missing or out of position.**

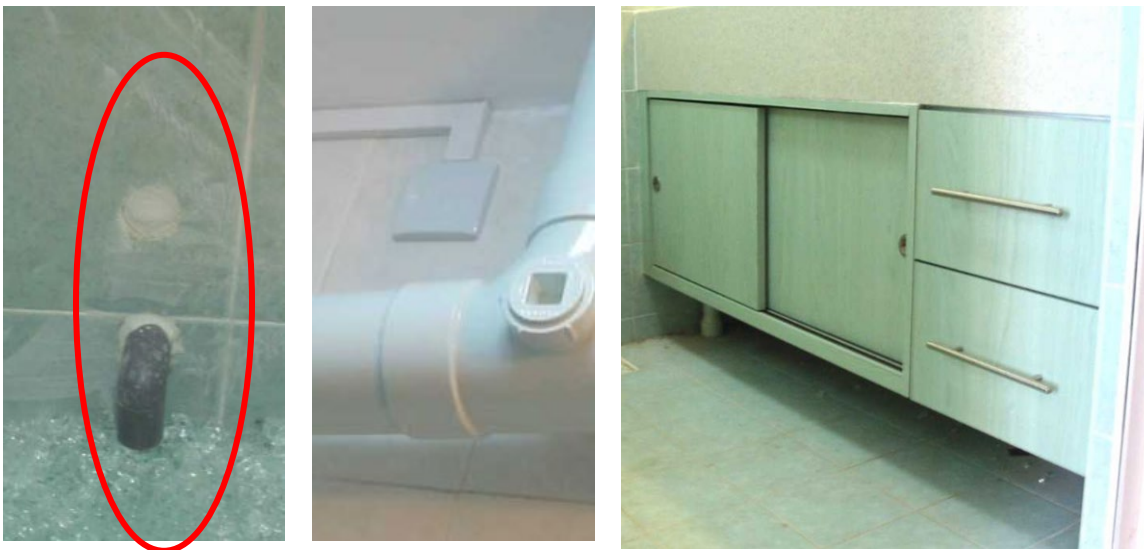
**renovation work items; were carried out at the scene of the incident.**

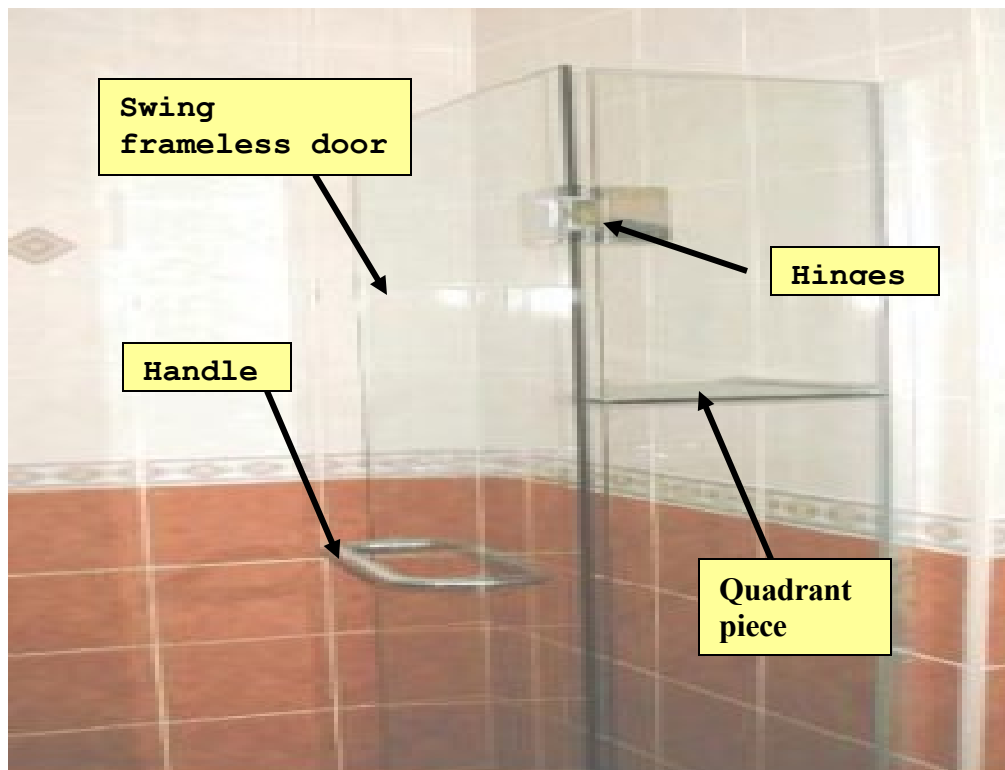
Inspection was conducted on the same day and due to the urgency of the case, a personal from Building Technology Department was called for joint inspection. It was noted that, the swing panel of 8mm thick frameless glass was totally shattered and the fixed panel was intact. The fixed panel was intact, as it may due to the installation of quadrant piece between two fixed panels which make it more stable.

As all the tempered glass was shattered, we cannot conclude or confirm the causes of failures. Common sources of failures may due to spontaneous fracture due to NiS inclusion (as feedback by Lessees) or external induced stress due to heavy impact on the swing door.

The Lessees even feedback that they felt the handle for the shower screen is heavy. From our data on shower screen, the handle is less than 2kg. HDB has experimented and conducted on 6mm thick tempered glass with load of 200kg before fracture occurred. The tempered glass door is held to fixed panel by the hinges. The hinges will grip the tempered glass in the slot, which is precut before the tempering process. Most tempered door is supported by this method as it provides a better stress distribution all around the tempered glass. Holding in by screws will create local stress concentration which will damage the tempered glass easily. Unless the tempered glass experience heavy impact due to swing, the possibility of it fracturing at he hinge area due to its self weight is minimal. (Annex 4: Site Investigation and Procedure for Shattering Shower Screen)
