<b>Content</b>	<b>Page</b>
Introduction	2
Infrared Thermography	3 - 5
Infrared Thermography Inspection on Electrical Components	6 - 11
Raytek Thermo View Ti30	12 - 13
Case Studies of Infrared Thermography for Electrical Appliances	
Common Problems in Electrical Circuit & Component	15
A Shopping Mall Summary Report & Thermographic Report	16 - 30
A Factory Summary Report & Thermographic Report	31 – 36
A HDB Flat's Lift Thermographic Report	37 – 38

# **CASE STUDIES REPORT**

**With the use of Raytek - ThermoView™ Ti30**

Project Name: Shopping Mall  
 Fault No: 01

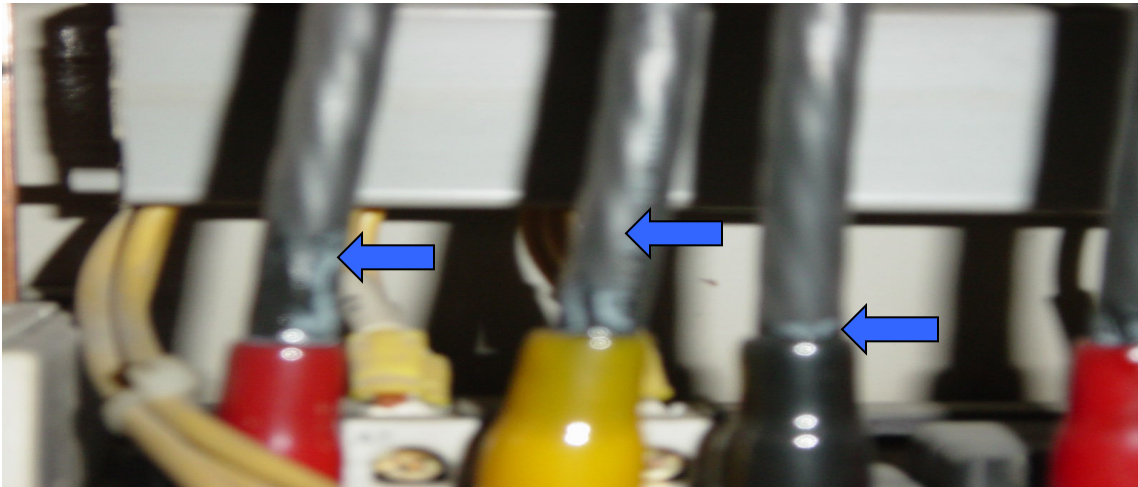
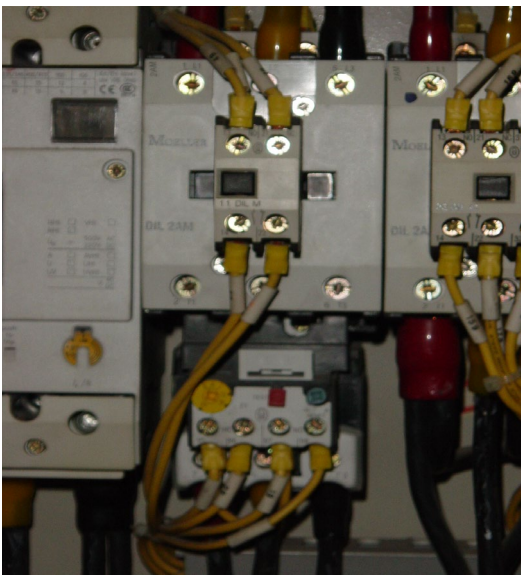
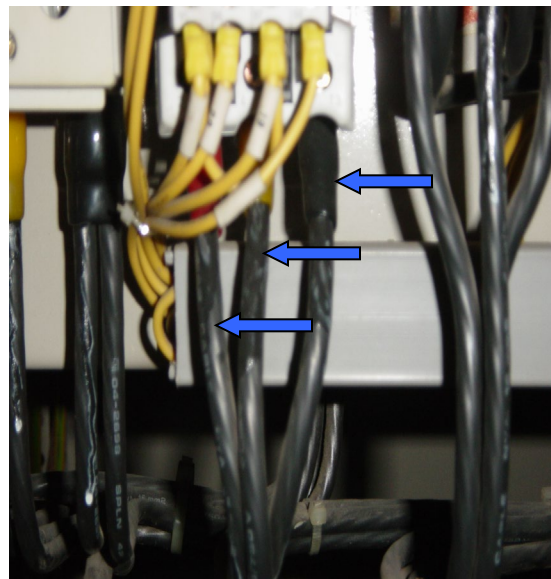
**Fault No. 3**

Deformation and discolourisation of cables are resultants of excessive heat loss from the cables and it might just weaken the whole cable insulation.

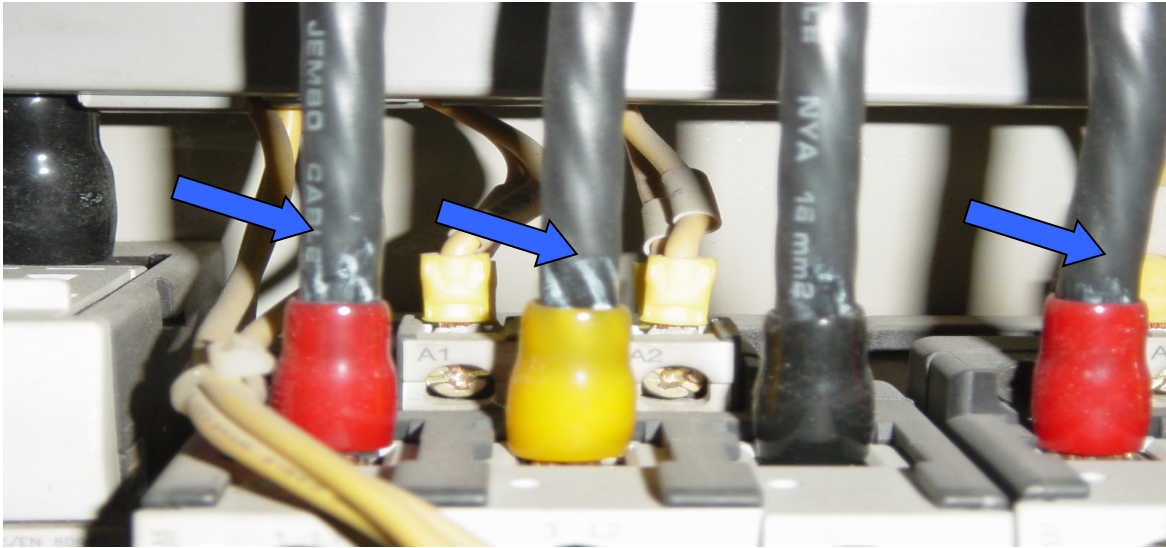
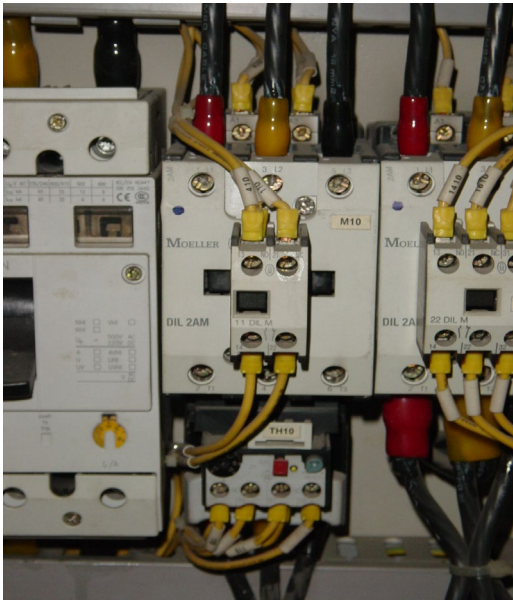
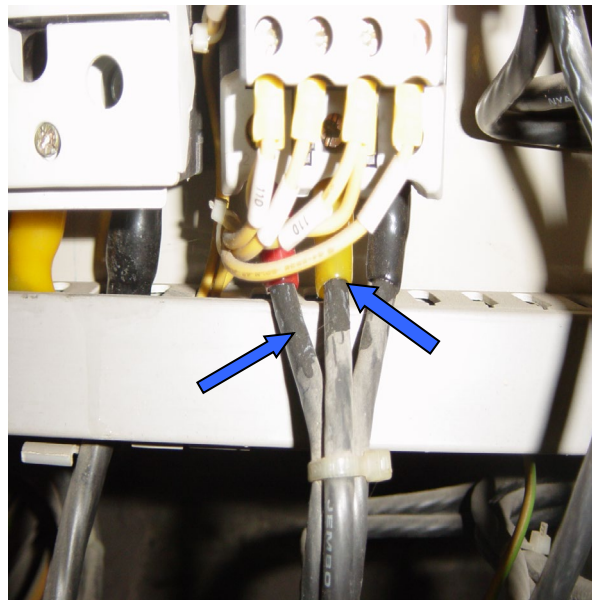
#### Fault No. 4

Deformation and discolourisation of cables are resultants of excessive heat loss from the cables and it might just weaken the whole cable insulation.

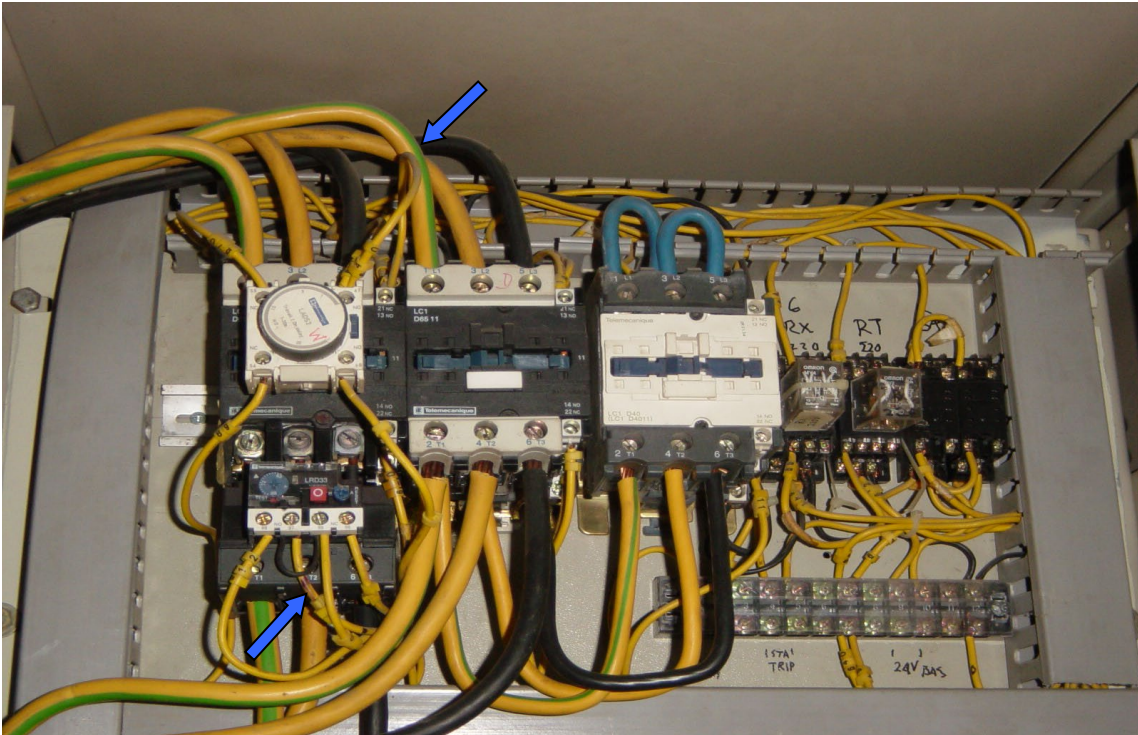
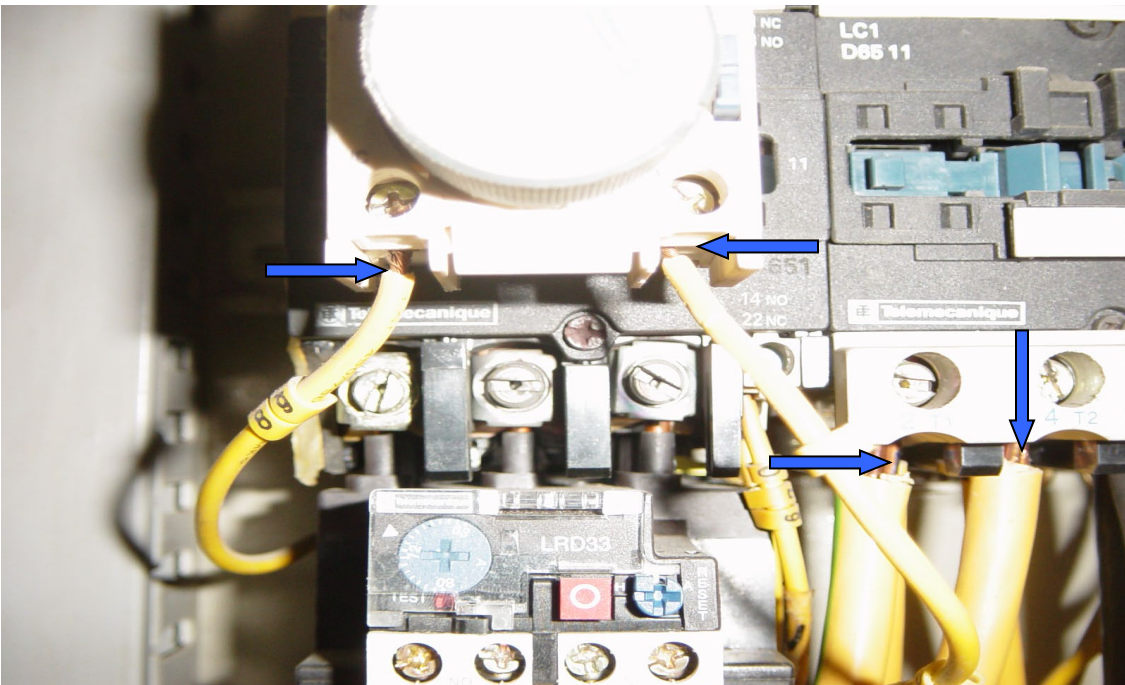
### Fault No. 5

Insulation to the cables is deformed. Burn marks are found on both the cable and cable terminations.

Improper cable terminations are dangerous and may lead to discharge and eventually flash over.

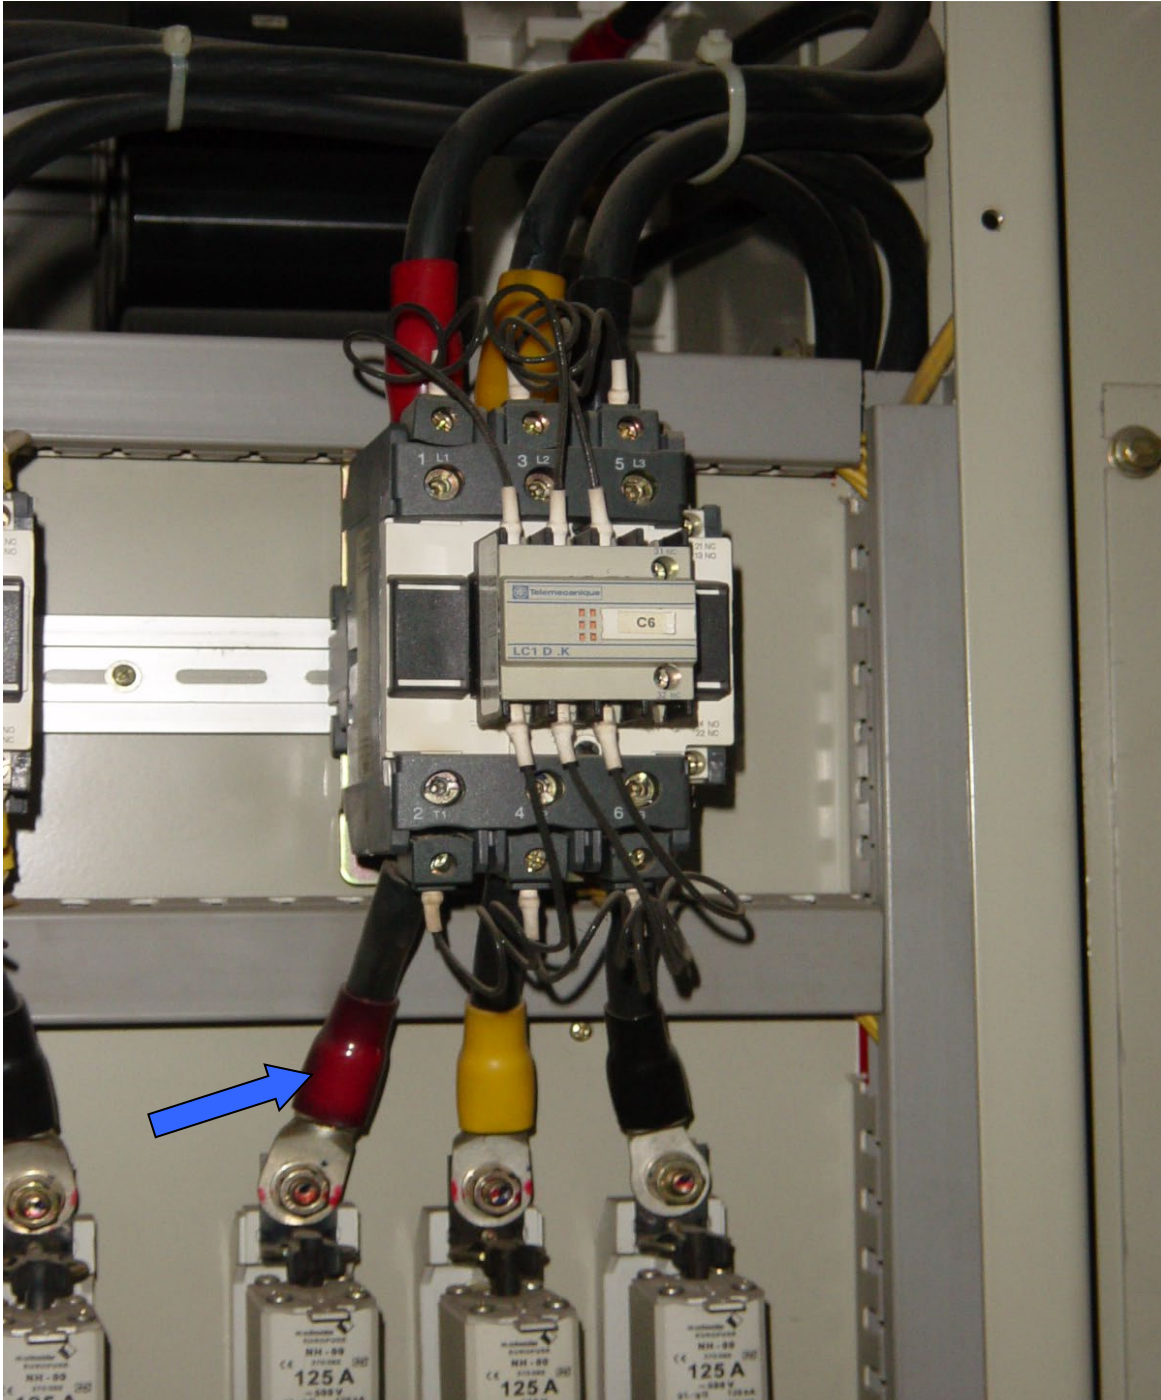
### Fault No. 6

Burnt marks are found on the R phase (unbalance loading at load side). Measure the load at each phase (R, Y, and B) and try to balance or transfer the loading on each phase.

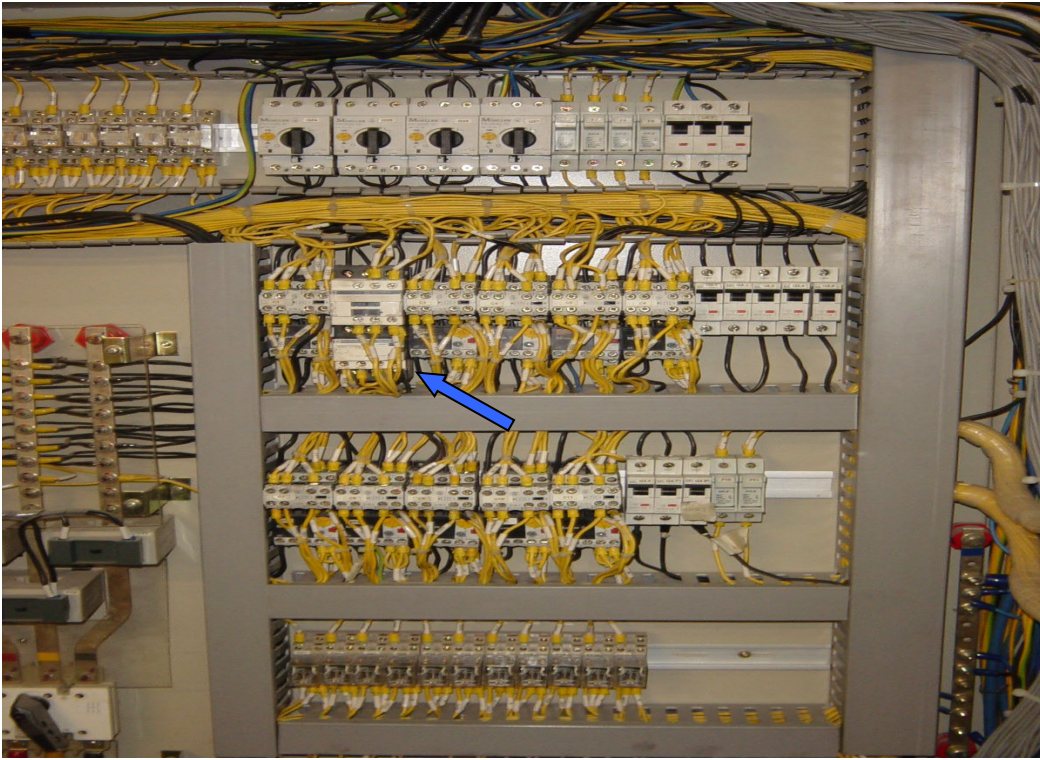
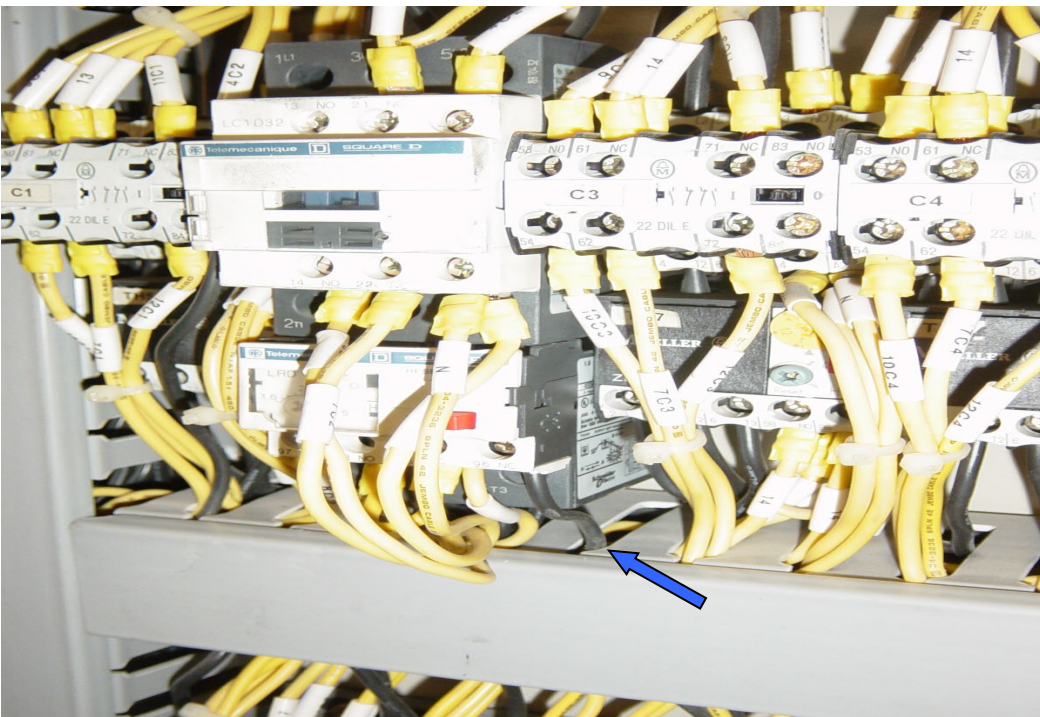
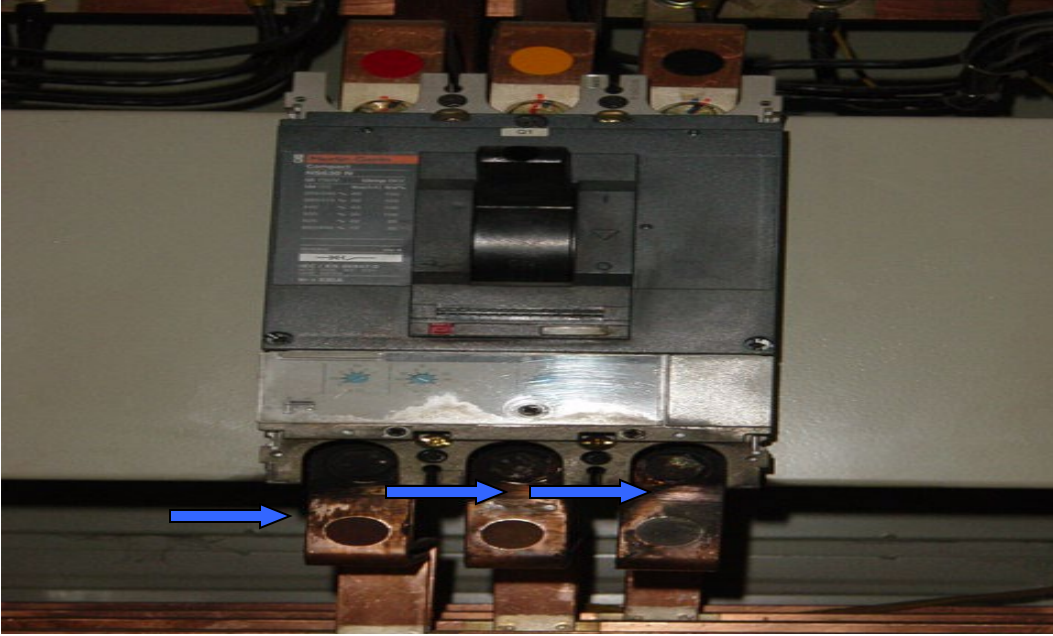
**Fault No. 7**

Carbonization on cable (might deteriorate the insulation and lead to flash over)

Burn marks on bus bar (clean and check for loose connections on bus bar during electrical maintenance).

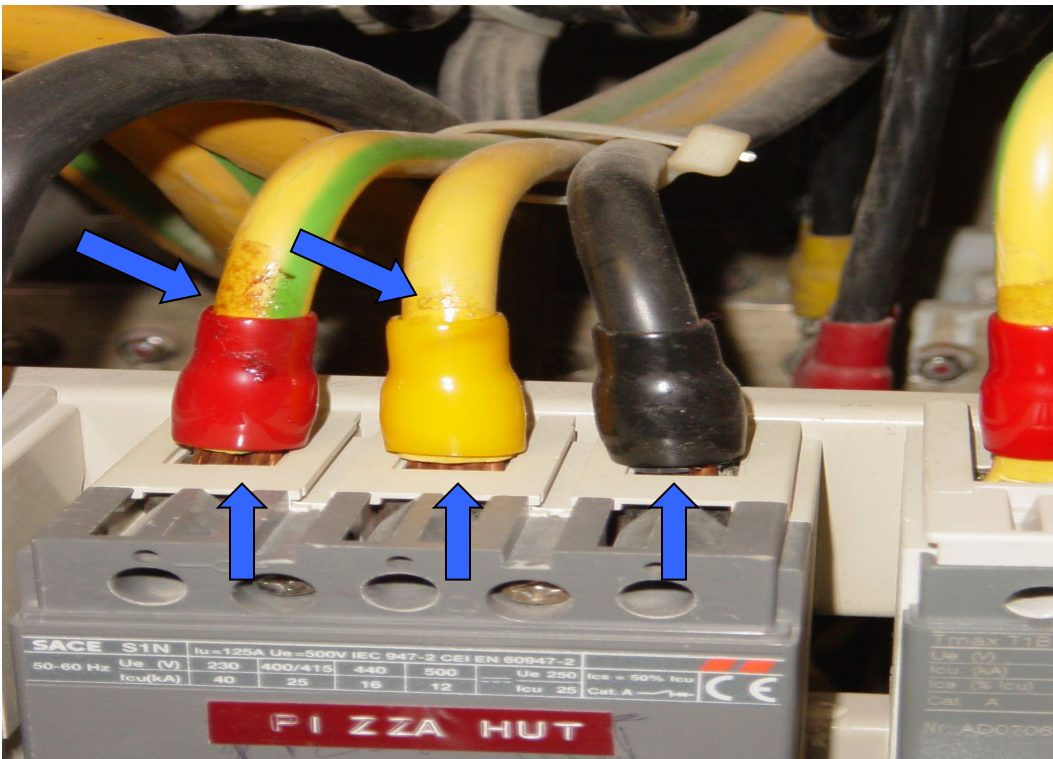
### Problem 8

Melted marks on cables insulation. Improper cables termination (check for loose any loose connections).

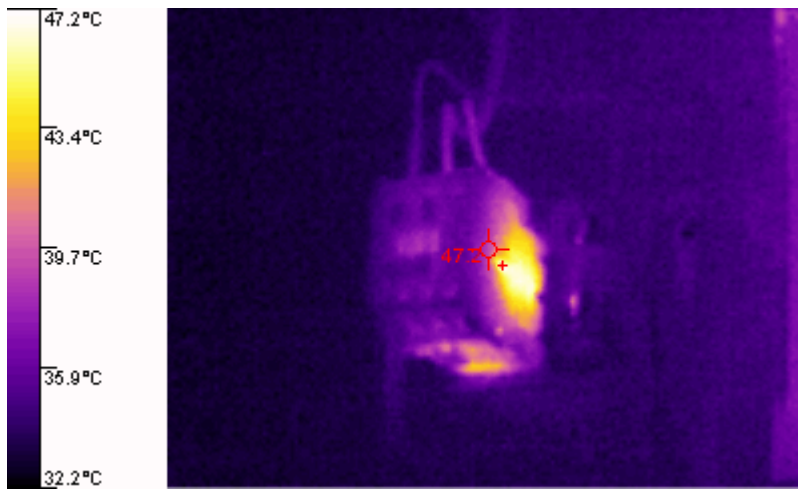
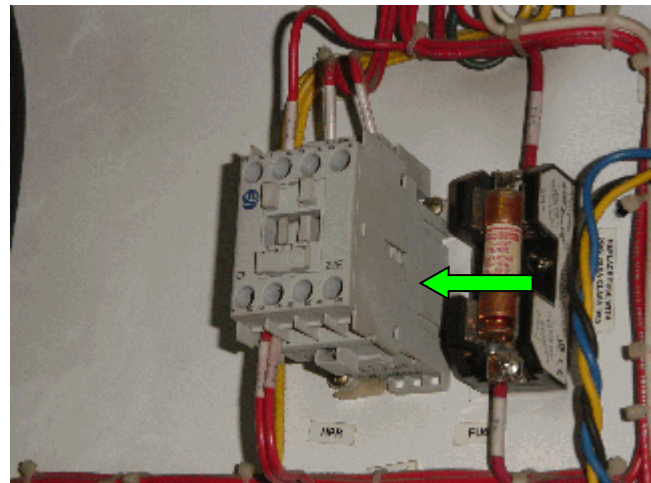
- HOT SPOT DETECTED

<b>Image Date</b>	May 2005
<b>Target Temperature</b>	47.2 °C
<b>Emissivity</b>	0.95
<b>Reflected Temp</b>	OFF

- Check the insulation resistance of the cable.
- Test the function of the contactor during regular electrical inspection.
- Secure the connection of the cable to the contactor.

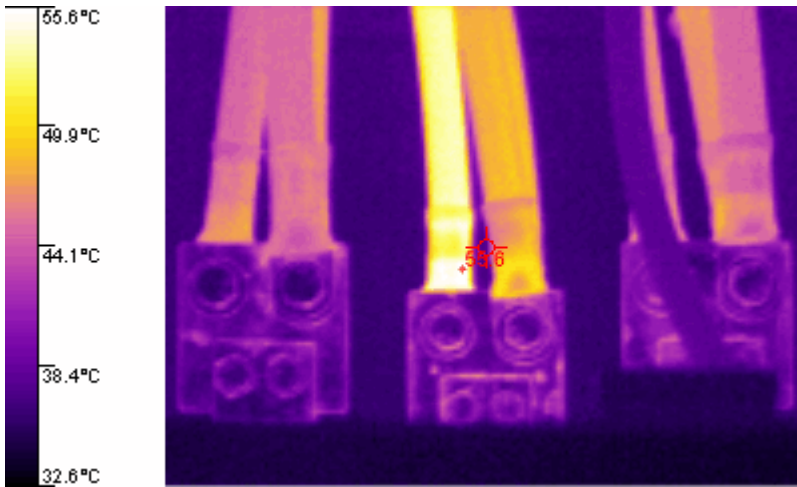
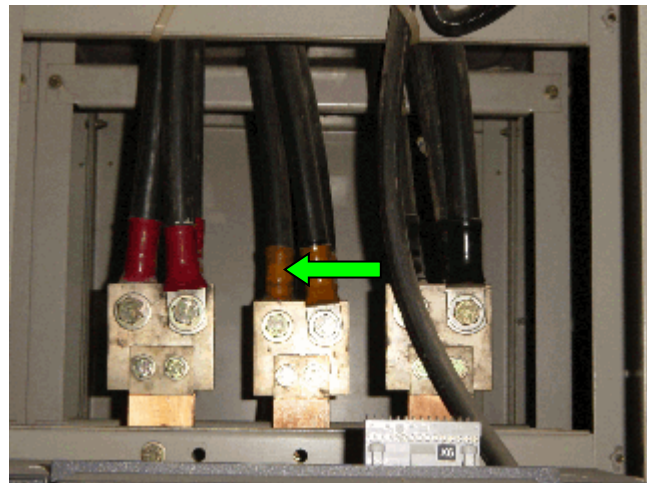
- HOT SPOT DETECTED

<b>Image Date</b>	May 2005
<b>Target Temperature</b>	55.6 °C
<b>Emissivity</b>	0.95
<b>Reflected Temp</b>	OFF

- Melted marks and discoloration of cable and cable sleeve were spotted (Insulation resistance check).
- Carbonization on cable and cable termination (clean and service during regular maintenance).
- Unbalance loading, check the load on each phase (R, Y, and B).

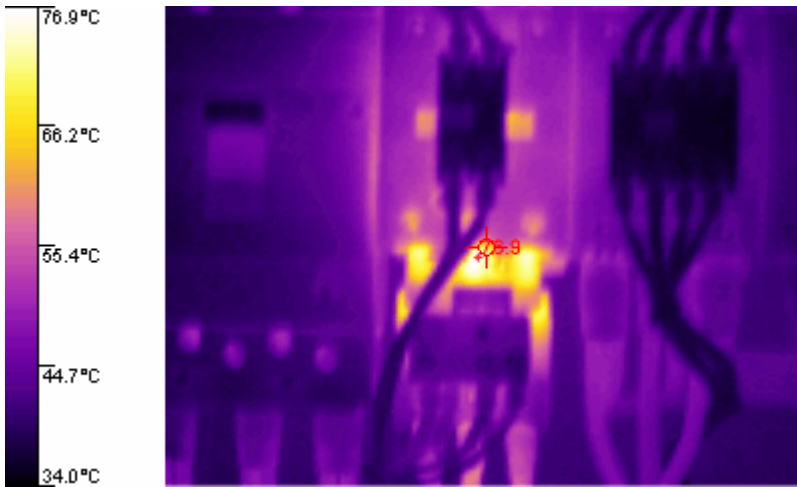
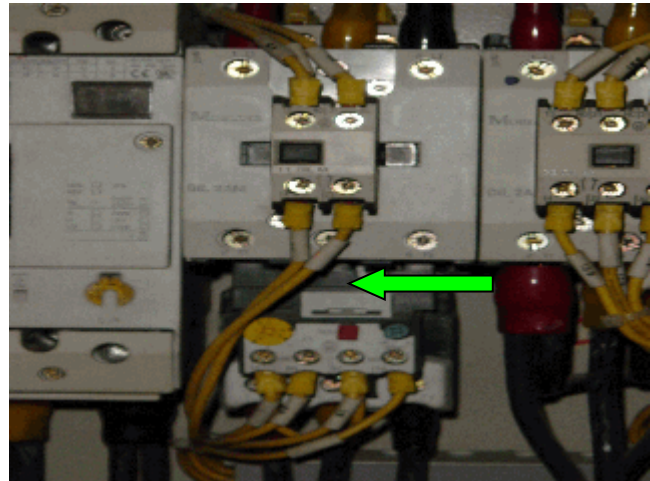
- HOT SPOT DETECTED

<b>Image Date</b>	May 2005
<b>Max. Temperature</b>	76.9 °C
<b>Emissivity</b>	0.95
<b>Reflected Temp</b>	OFF

- Discoloured cables insulation. Deformed of cable insulation was spotted (Insulation resistance check).
- Test the function of the relay.
- Check for loose connections of the contactor, relay and the cables (secure the connections).

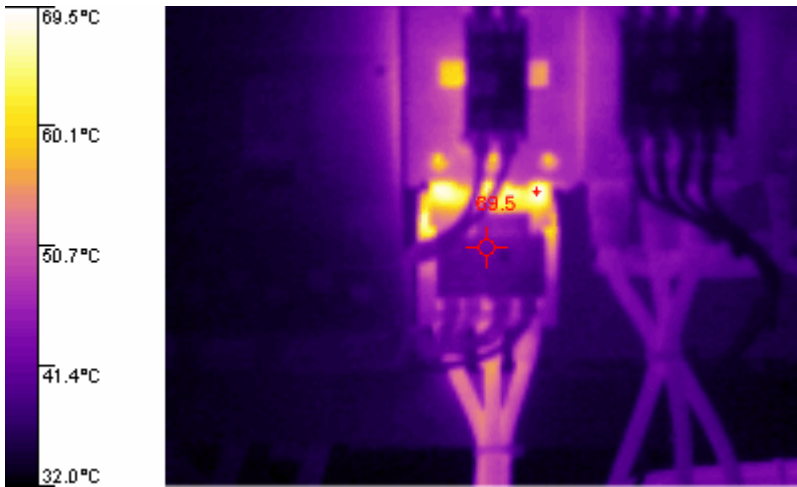
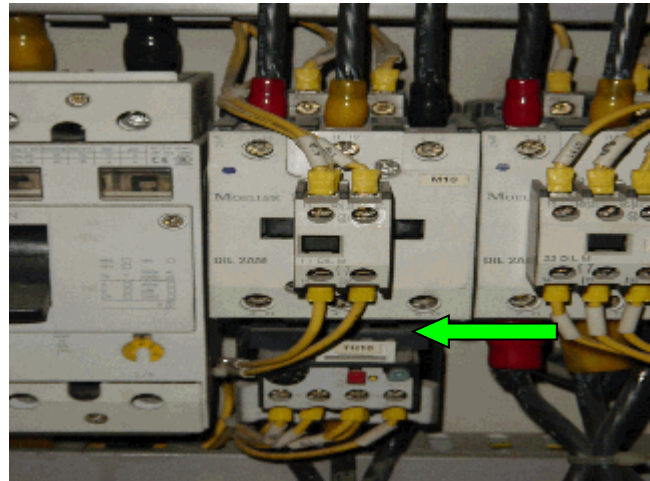
- HOT SPOT DETECTED

<b>Image Date</b>	May 2005
<b>Max. Temperature</b>	69.5 °C
<b>Emissivity</b>	0.95
<b>Reflected Temp</b>	OFF

- Discoloured cables insulation. Deformed of cable insulation was spotted (Insulation resistance check).
- Test the function of the relay.
- Check for loose connections of the contactor, relay and the cables (secure the connections).

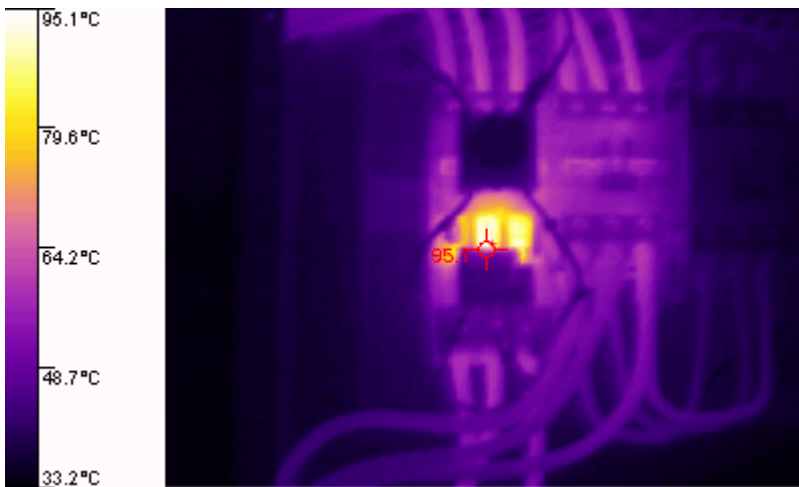
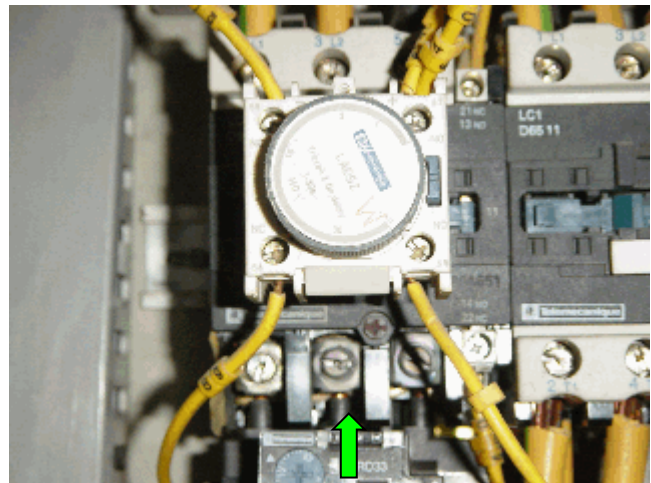
- HOT SPOTS DETECTED

<b>Image Date</b>	May 2005
<b>Max. Temperature</b>	95.1 °C
<b>Emissivity</b>	0.95
<b>Reflected Temp</b>	OFF

- Improper cable terminations (bare wire), Burn marks were spotted on cables and cable terminations.
- Deformed cable insulation spotted (Insulation resistance test).
- Check the function of the contactor, relay and the on delay timer. Check for loose connections of components.

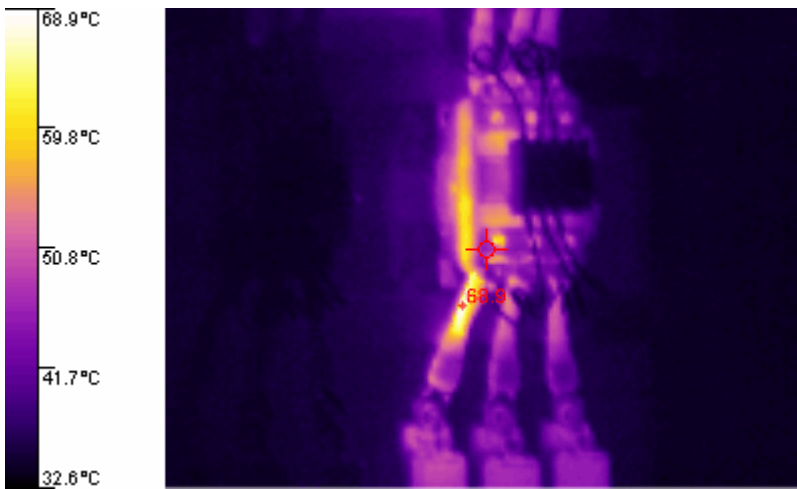
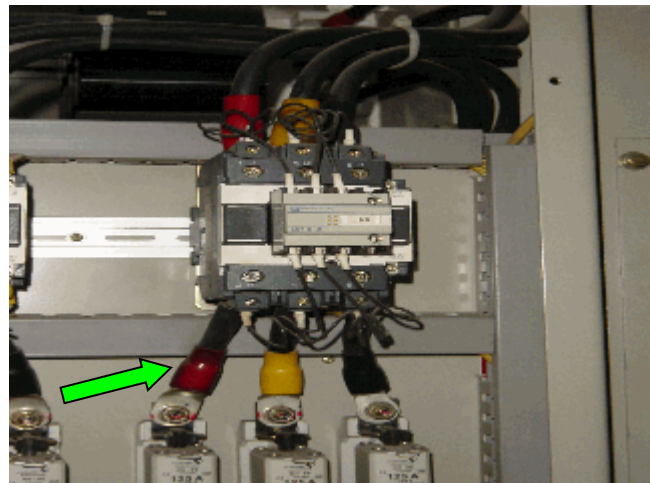
- HOT SPOT DETECTED

<b>Image Date</b>	May 2005
<b>Max. Temperature</b>	68.9 °C
<b>Emissivity</b>	0.95
<b>Reflected Temp</b>	OFF

- Burn mark spotted on the R phase.
- Check for loose connections (secure loose connection if any).
- Measure the load on each phase (Unbalance loading at load side).

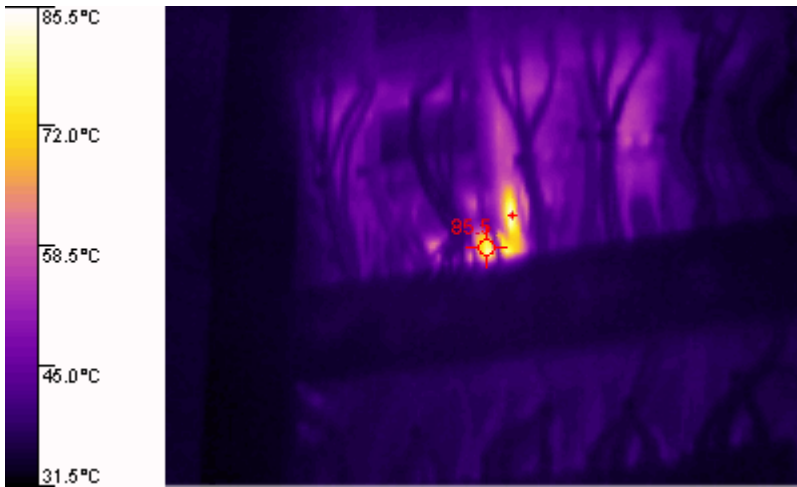
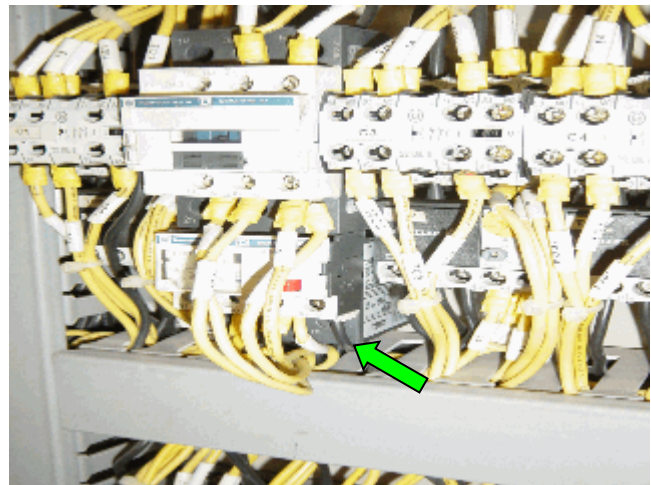
- HOT SPOT DETECTED

<b>Image Date</b>	May 2005
<b>Max. Temperature</b>	85.5 °C
<b>Emissivity</b>	0.95
<b>Reflected Temp</b>	OFF

- Carbonization and discolouring was spotted on cable (Insulation resistance test).
- Check for loose connections and test the function of the contactor (secure loose connections if any).

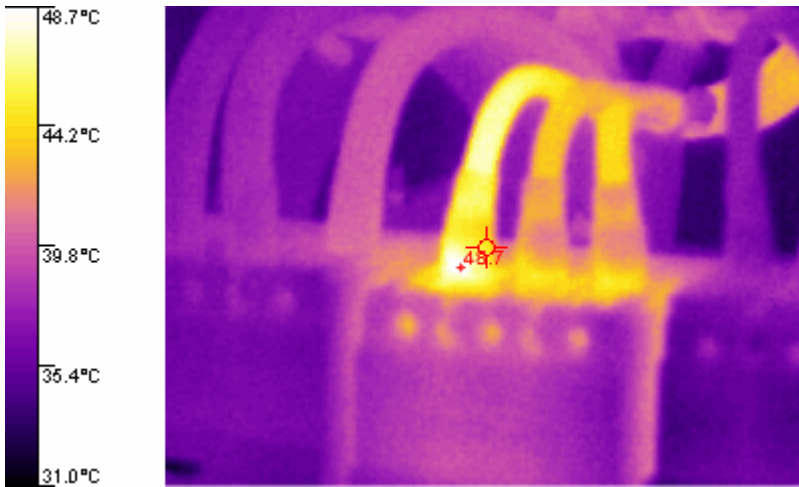
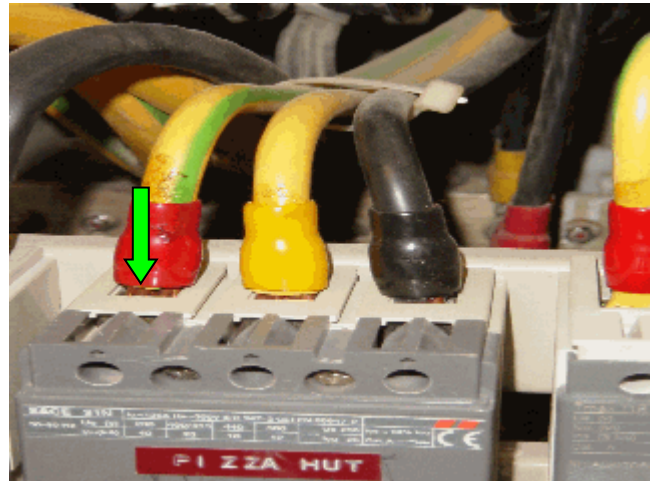
- HOT SPOT DETECTED

Image Date	May 2005
Max. Temperature	48.7 °C
Emissivity	0.95
Reflected Temp	OFF

- Improper cable terminations (bare wire), melted marks spotted on cables.
- Check for loose connections (secure loose connections if any).

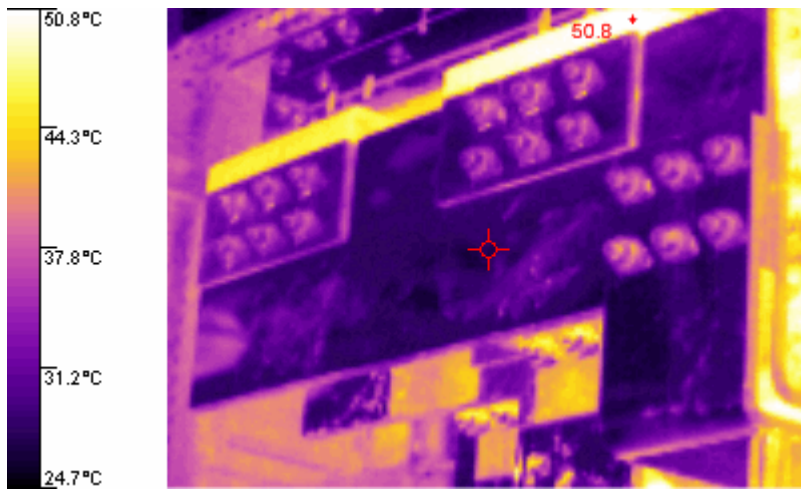
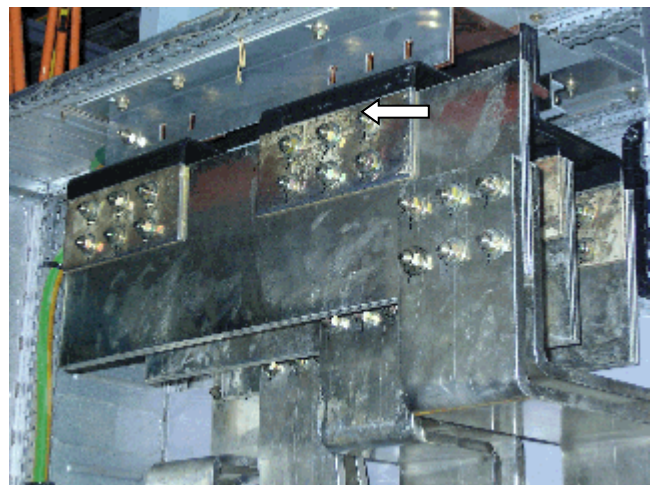
- HOT SPOT DETECTED

<b>Image Date</b>	Sept 2005
<b>Max. Temperature</b>	50.8 °C
<b>Emissivity</b>	0.95
<b>Reflected Temp</b>	OFF

- To clean and service during shut down maintenance (thick carbon particles were found all over the bus bars).
- Deep scratches marks were found all over the bus bars (to be rectified).

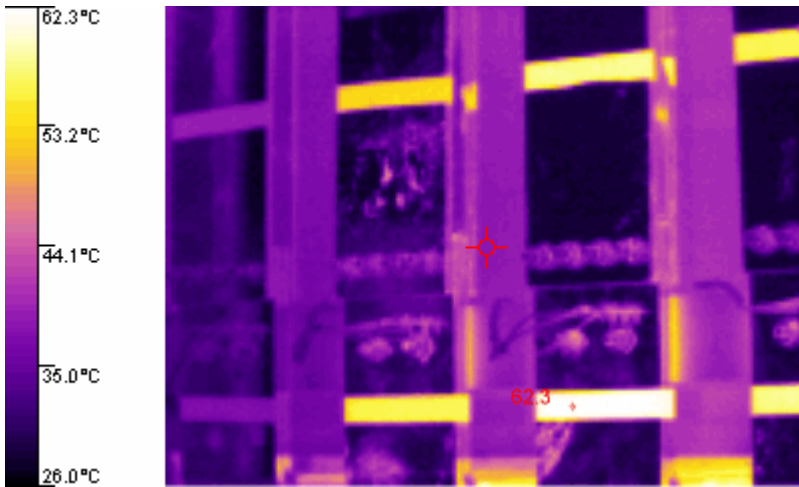
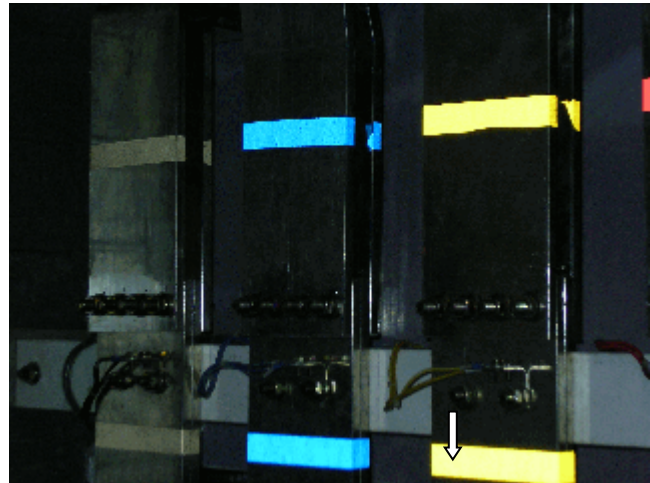
- HOT SPOT DETECTED

<b>Image Date</b>	Sept 2005 AM
<b>Max. Temperature</b>	62.3 °C
<b>Emissivity</b>	0.95
<b>Reflected Temp</b>	OFF

- To clean and service during shut down maintenance (thick carbon particles were found all over the bus bar connections).
- Deep scratches marks were found on bus bar connection (to be rectified).
- To secure the connections of the bus bar during shut down maintenance.

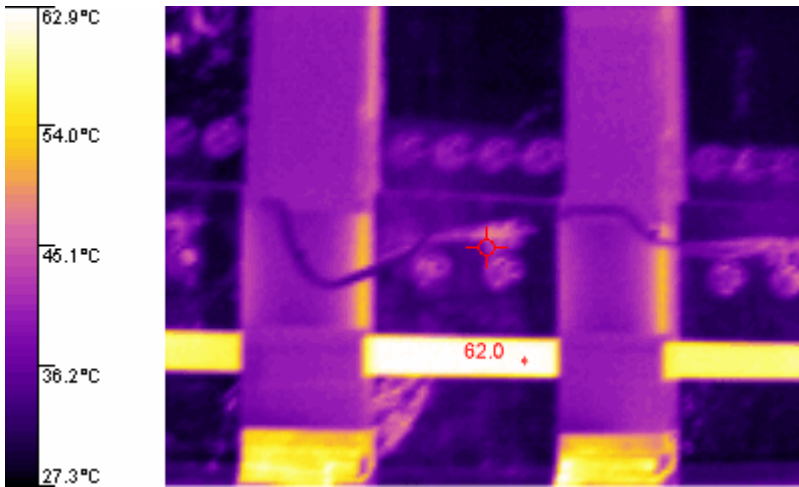
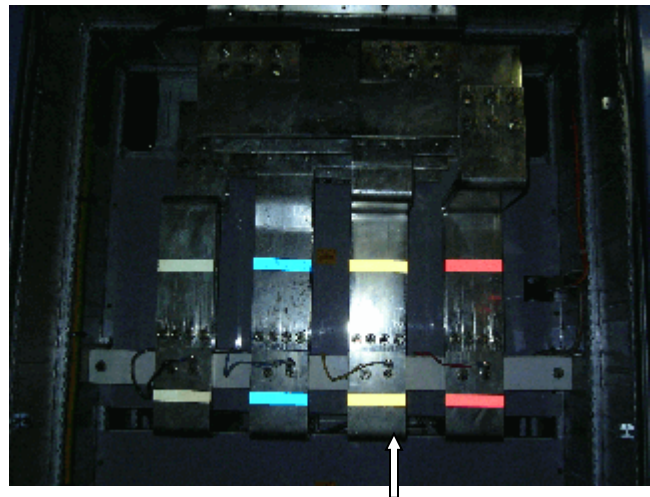
- HOT SPOT DETECTED

<b>Image Date</b>	Sept 2005
<b>Max. Temperature</b>	62 °C
<b>Emissivity</b>	0.95
<b>Reflected Temp</b>	OFF

- To clean and service during shut down maintenance (carbon particles were found all over the bus bars).
- Deep scratches marks were found all over the bus bars (to be rectified).
- To secure the connections of the bus bar during shut down maintenance.

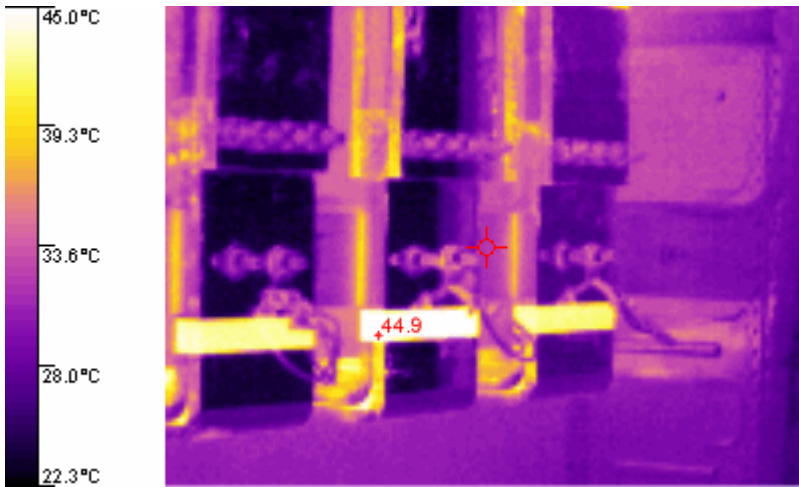
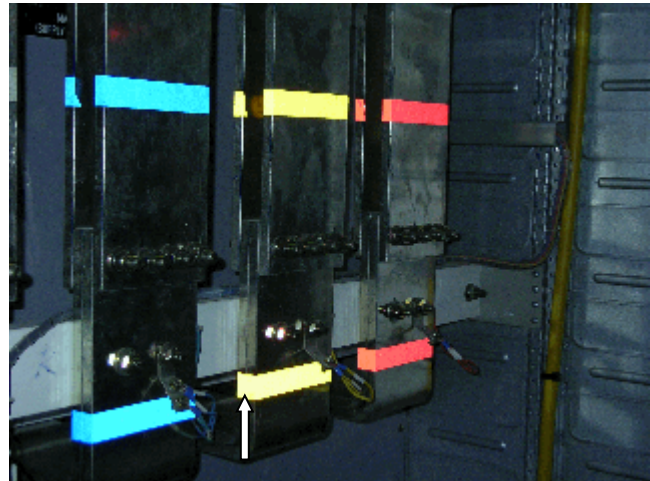
- HOT SPOT DETECTED

<b>Image Date</b>	Sept 2005
<b>Max. Temperature</b>	44.9°C
<b>Emissivity</b>	0.95
<b>Reflected Temp</b>	OFF

- To clean and service during shut down maintenance (carbon particles were found all over the bus bars).
- To secure the connections of the bus bar during shut down maintenance.

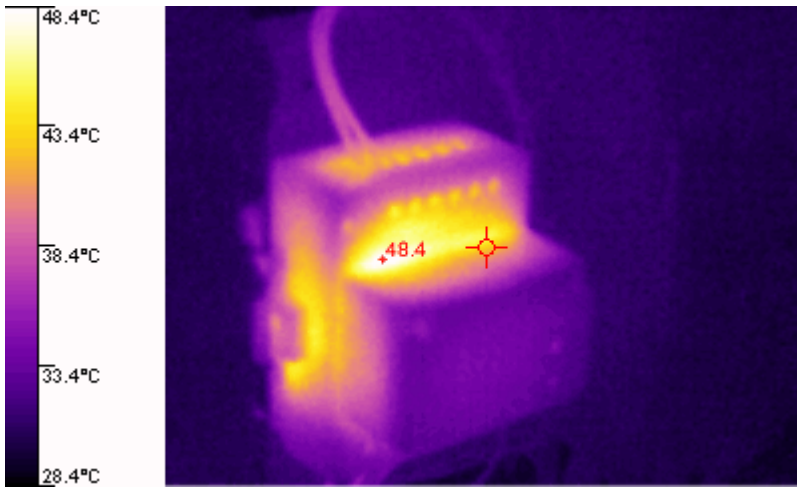
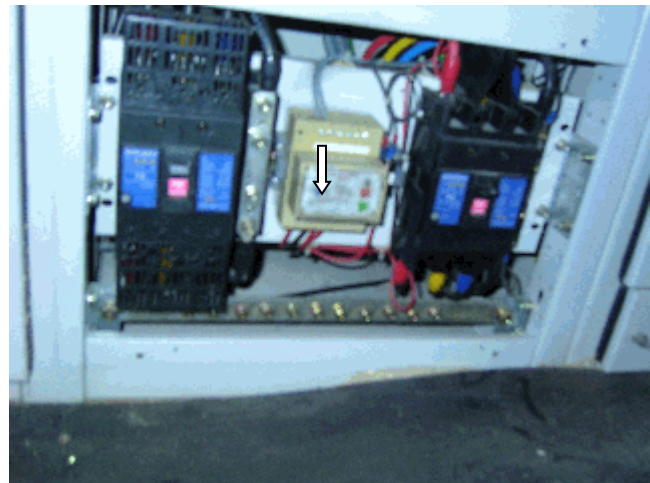
**Location Name** | Switch Room  
**Equipment** | Earth leakage relay

- Hot spot detected

<b>Image Date</b>	Feb 2005
<b>Target Temperature</b>	48.4 °C
<b>Emissivity</b>	1.00
<b>Reflected Temp</b>	OFF

- Check the connections of the Earth leakage relay
- Check on the Earth leakage relay

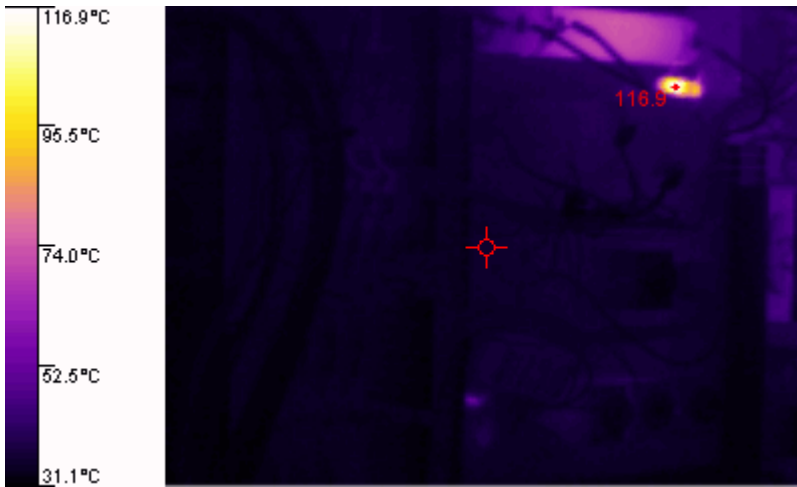
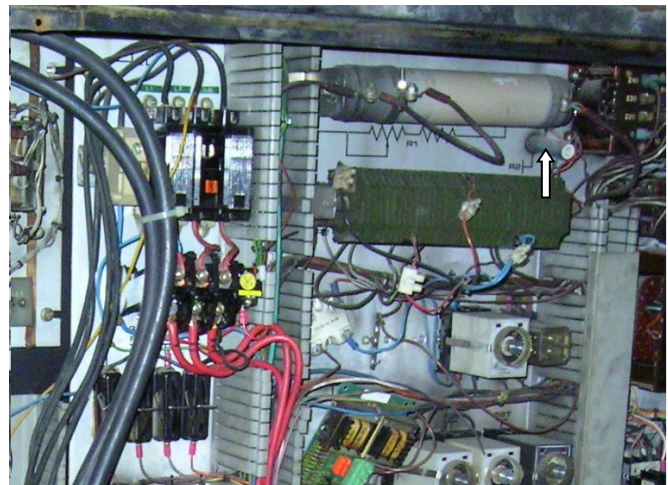
- Hot spot detected

<b>Image Date</b>	Feb 2005
<b>Target Temperature</b>	116.9 °C
<b>Emissivity</b>	1.00
<b>Reflected Temp</b>	OFF

- Check the component R2 where hot spot was detected
- Check the connections
- Replace component as soon as possible
