Spontaneous Shattering of Tempered Glass

*Wong CW, HC Tan and Chew SC
Setsco Services Pte Ltd*

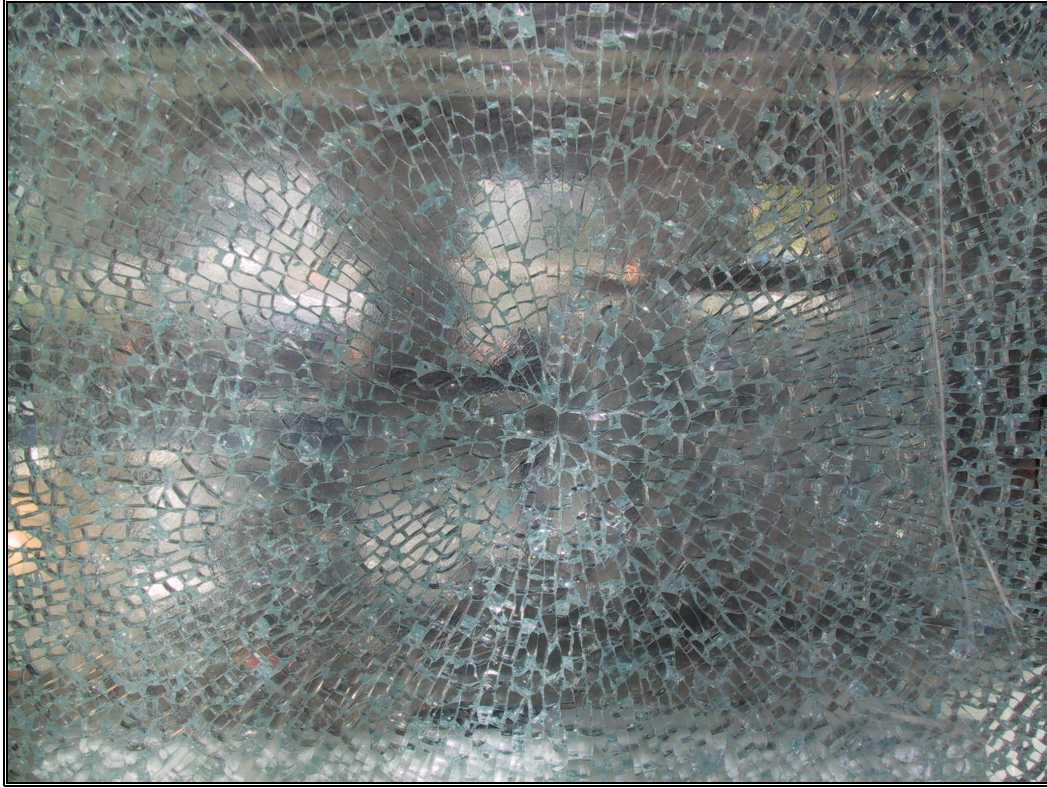
Tempered glass is about 4 times stronger than annealed glass due to the level of compression at the surfaces and edges. When tempered glass breaks, all the stored energy is released at once and the glass breaks into small fragments, also called dices. When a flaw occurs in the central tensile zone of a tempered glass lite, the glass may shatter spontaneously without any apparent cause or warning. If the glass fragments remain intact in the opening, the origin of fracture is apparent from its sunburst crack pattern (Figure 1).

Figure 1: Sun-burst crack pattern of spontaneous breakage caused by expansion of Nickel Sulphide inclusion

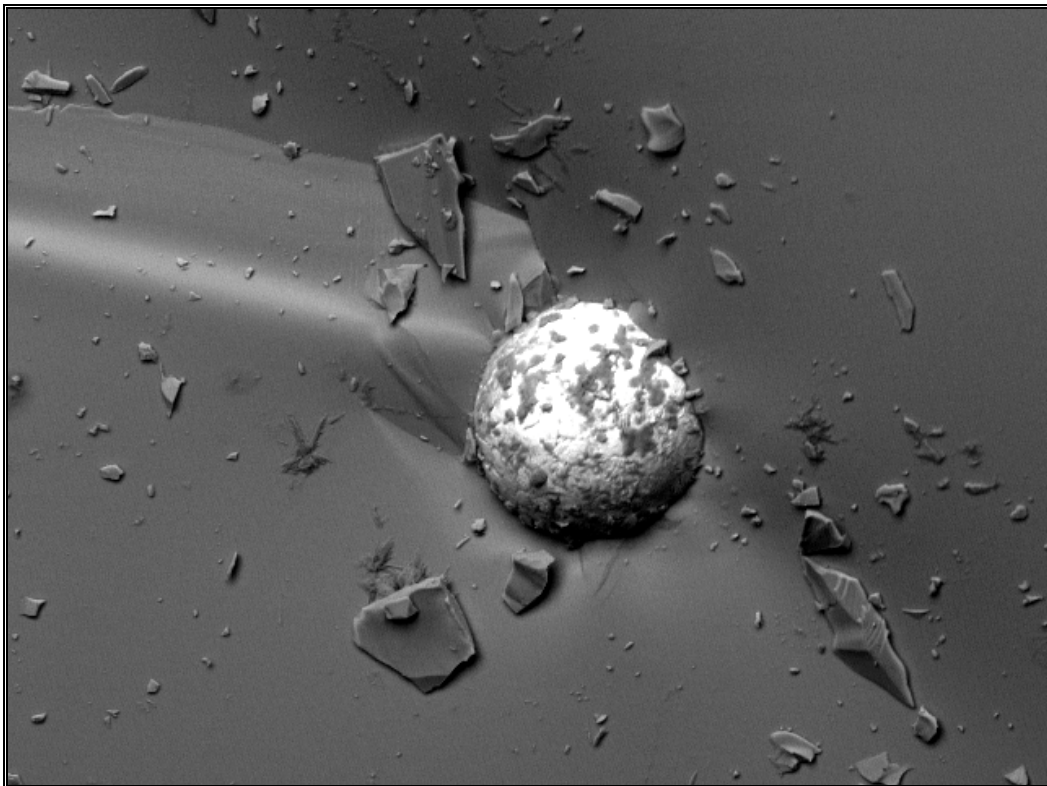
These impurities or stones are minute in size generally ranging from 50 to 150 microns and usually spherical or slightly spheroidal. (Figure 2). From the authors' experience, size of inclusions more than 500 microns have also been identified. They are impossible to totally eliminate, not easily visible in the glass substrate and not considered a product defect in annealed (raw) glass.

Figure 2: Backscattered image of Nickel Sulphide embedded in the glass (image magnified at 450 times)

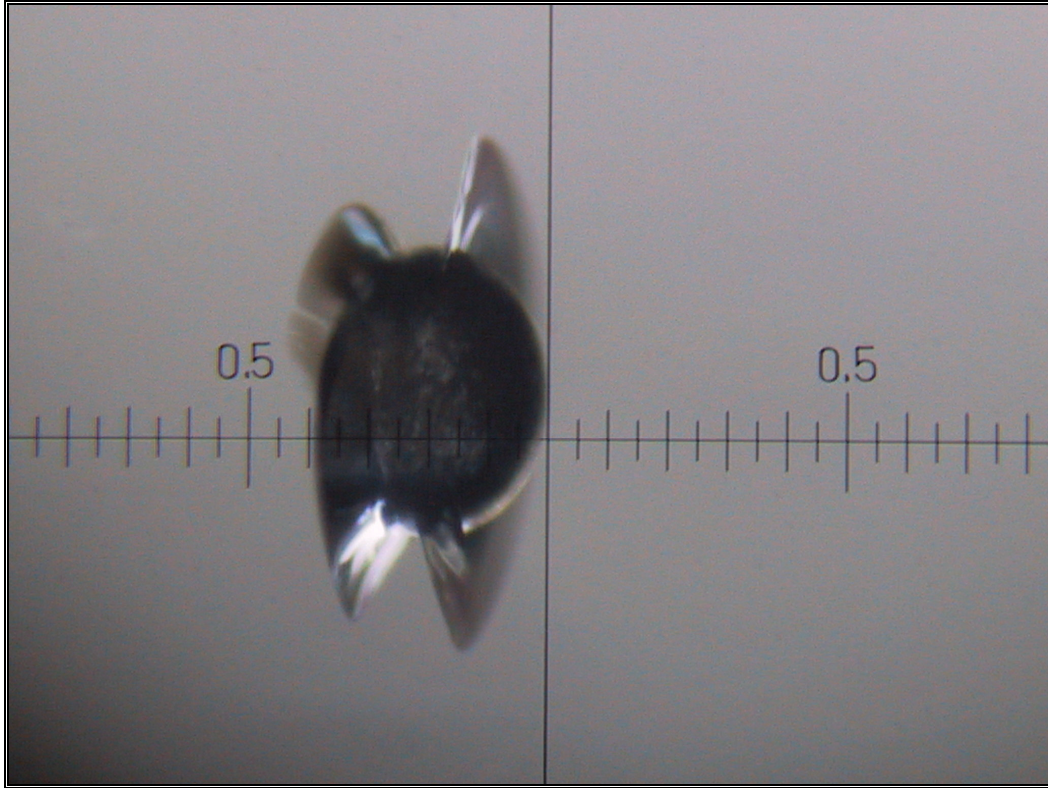
The authors meanwhile have been relying on a combination of the polarised light and visual inspection. Though, such inspection is very tedious and time consuming, it has proven reliable to detect the presence of NiS inclusion (Figure 3) and thereby assess the risk of potential failure. During the course of the inspection, other telltale sign that indicate potential failure will also be identified. From the large numbers of glass inspected over the years, experience tells us that there are many other factors, which may cause the glass to shatter suddenly. These include deep scratches, weld splatter, edge spall and shells (Figure 4 to 8).

Figure 3: Inclusion in glass with possible fracture planes

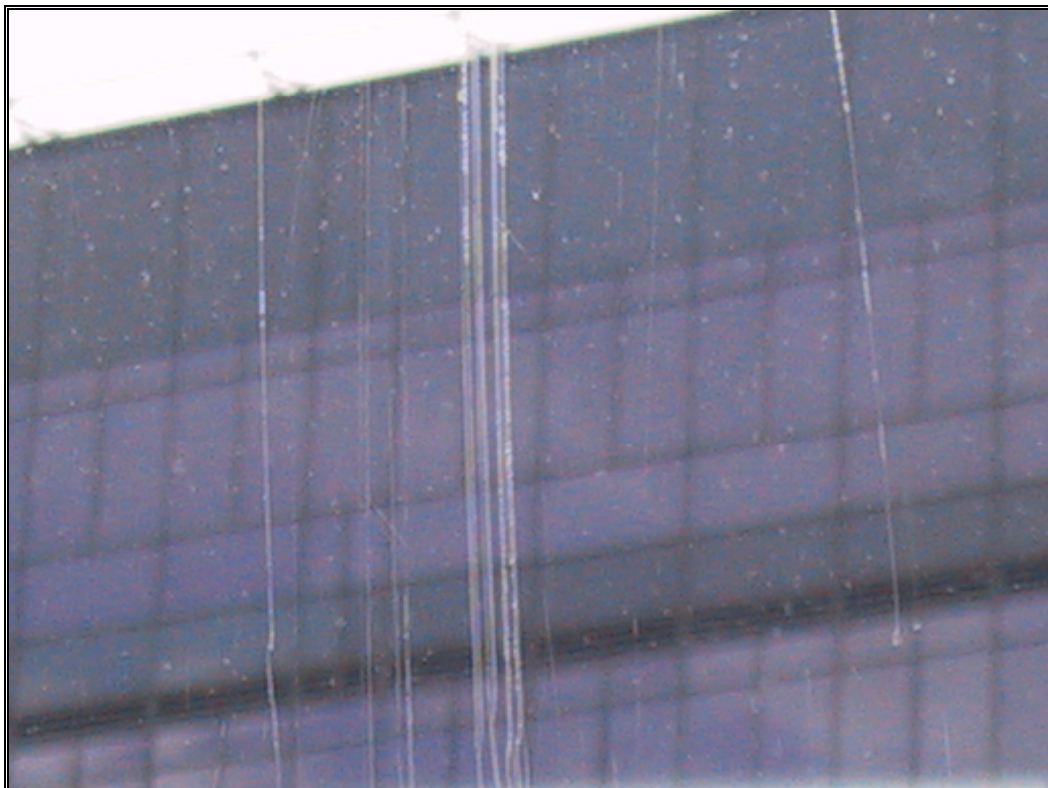
Figure 4: Deep scratches

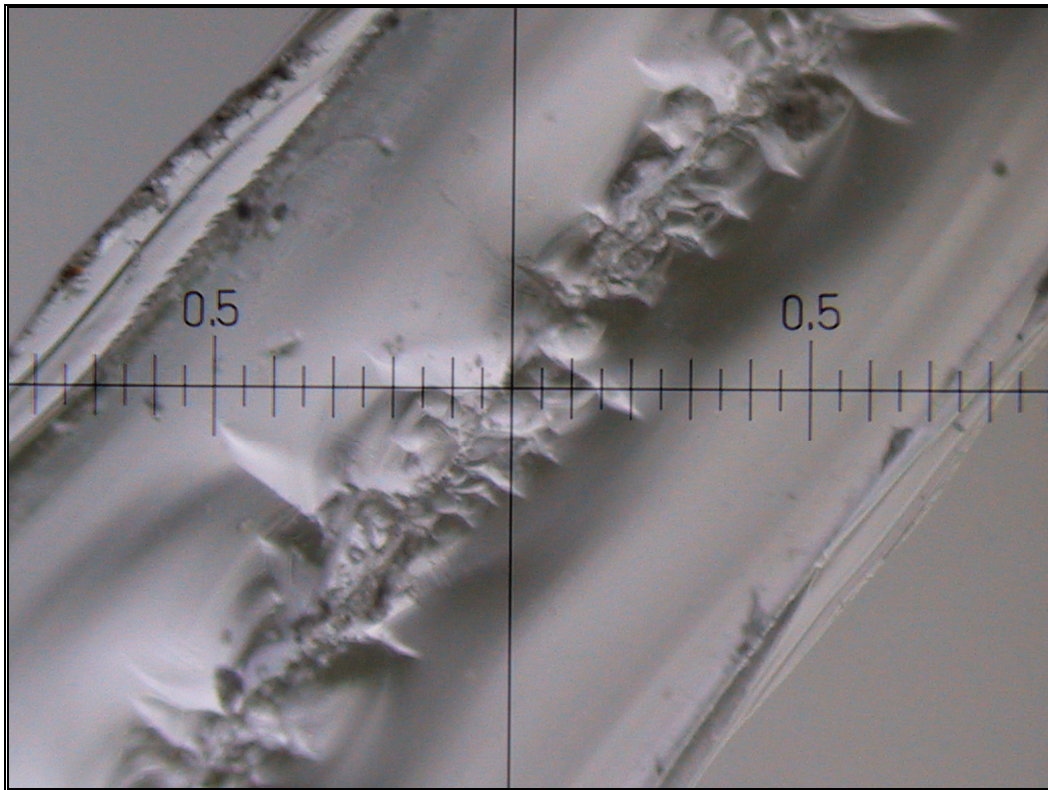
Figure 5: Deep scratches under microscopic view

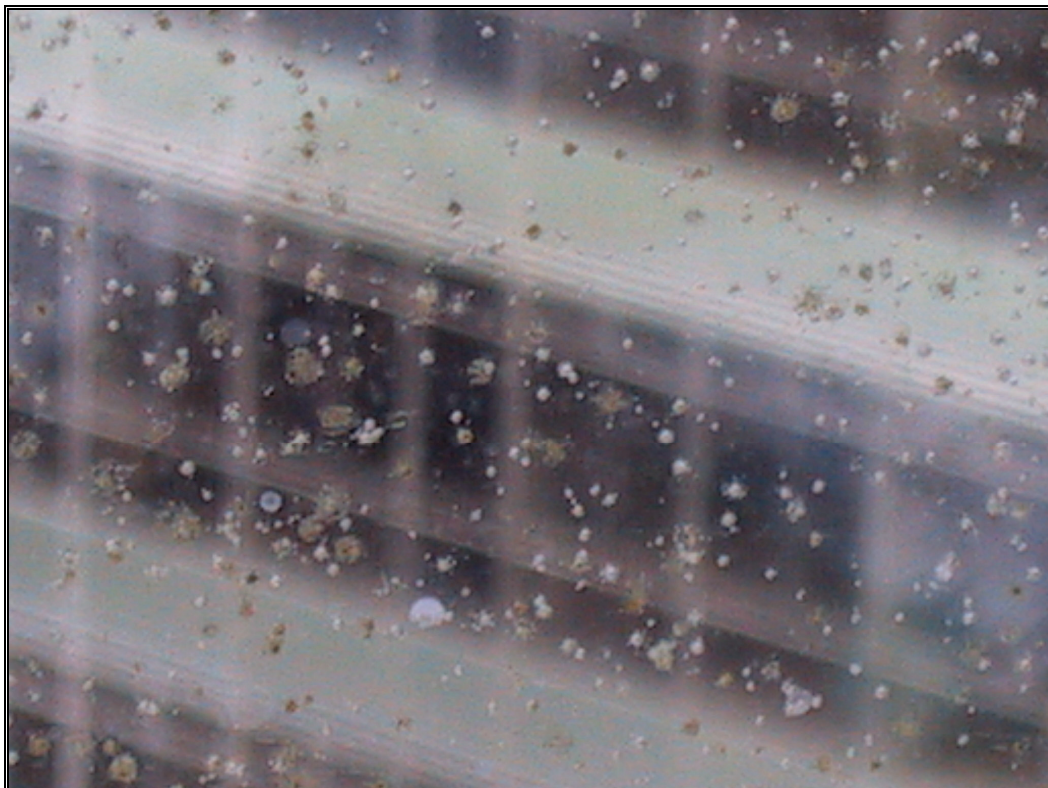
Figure 6: Typical weld splatter on glass

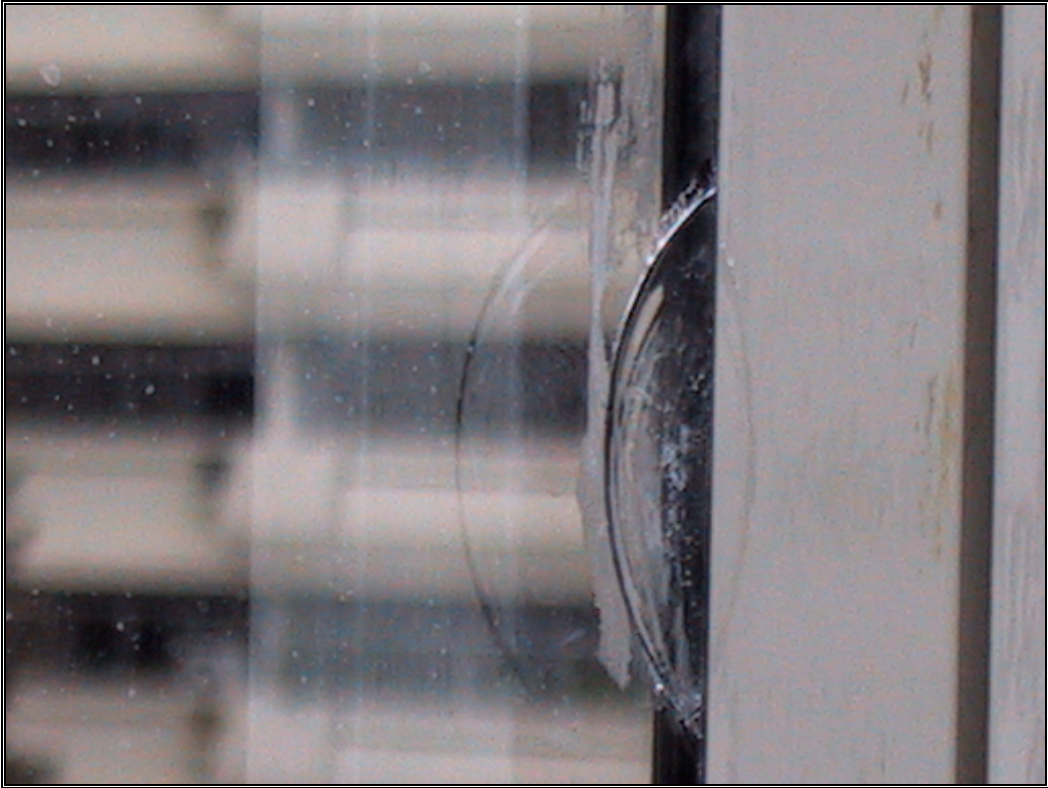
Figure 7: Edge spall
