114 Staining of Facades

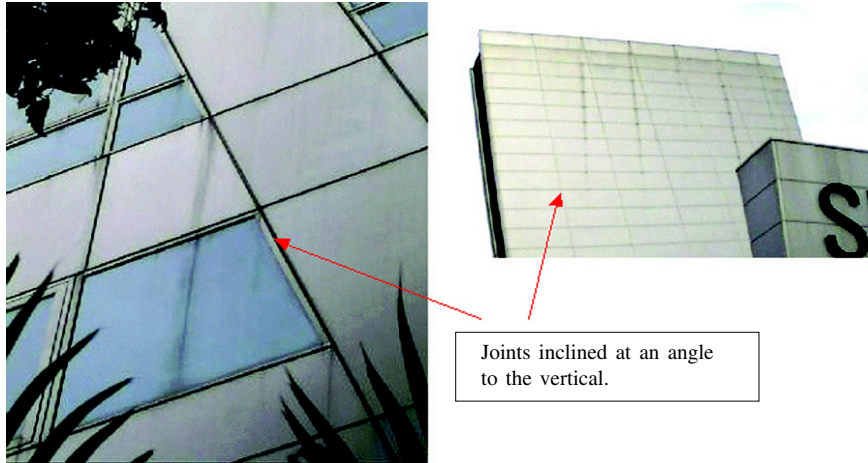
Figure 4.25. Joints inclined at an angle to the vertical.

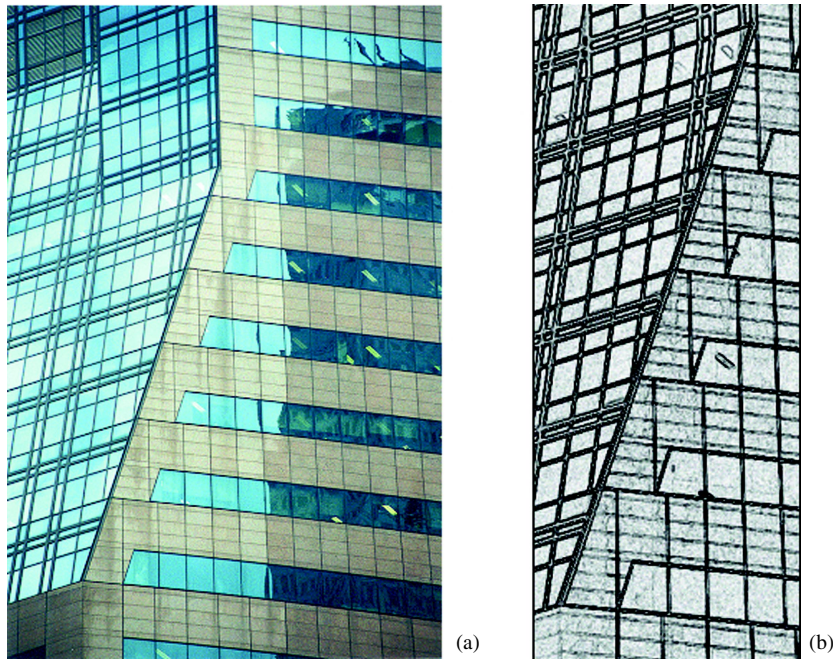
Figure 4.26. (a) Joints misalignment on the facade of the building interrupts the even flow of runoff and results in staining. (b) Drawing shows the clear misalignment of joints.

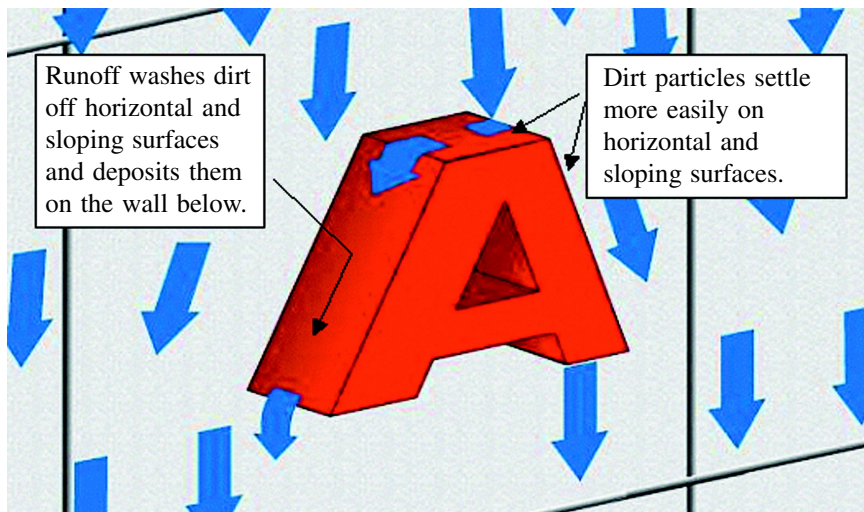
Figure 4.32. Runoff flow pattern over a signage to cause the resulting staining pattern.

The mechanism by which stain marks form around signage is very much similar to that of stains formed around protruding fixtures. This is illustrated in Fig. 4.32.

letterings are fixed directly to the facade without clearance between the facade and the letterings, thus, dirt gathered on the lettering is washed onto the facade (Fig. 4.32). In the latter case, the letterings are not in direct contact with the facade and stains begin at the attachment points

By comparing the two methods of attaching fixtures to the facade as shown in Figs. 4.32 and 4.35, it is evident that by allowing a clearance between the facade and the fixture, runoff would be able to flow with minimal disturbance and staining below the protrusion would be minimised. When selecting the material for the attachment, more

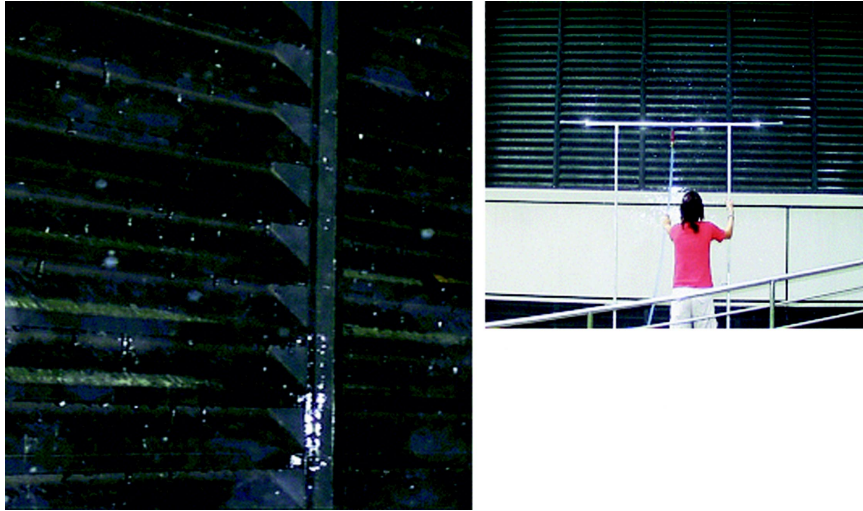
Figure 4.40. Random runoff flow pattern from louver pane to pane. Experimental setup.

A rain simulation experiment conducted on a typical louver unit also demonstrated similar runoff flow pattern (Fig. 4.40). It was shown that the dripping of runoff down the louver unit was random and unpredictable and there was no defined location where drips were more concentrated.
