Slips and Falls – Risks for Pedestrians

Abstract

Pendulum slip resistance tests were conducted on 12 sites covering ceramic tiles, pebbles, and features such as tactile indicators, and manhole covers. The results show that the reduction of frictional resistance can be reduced up to 3 times when tested wet. The slip can be exacerbated when it is on a slope.

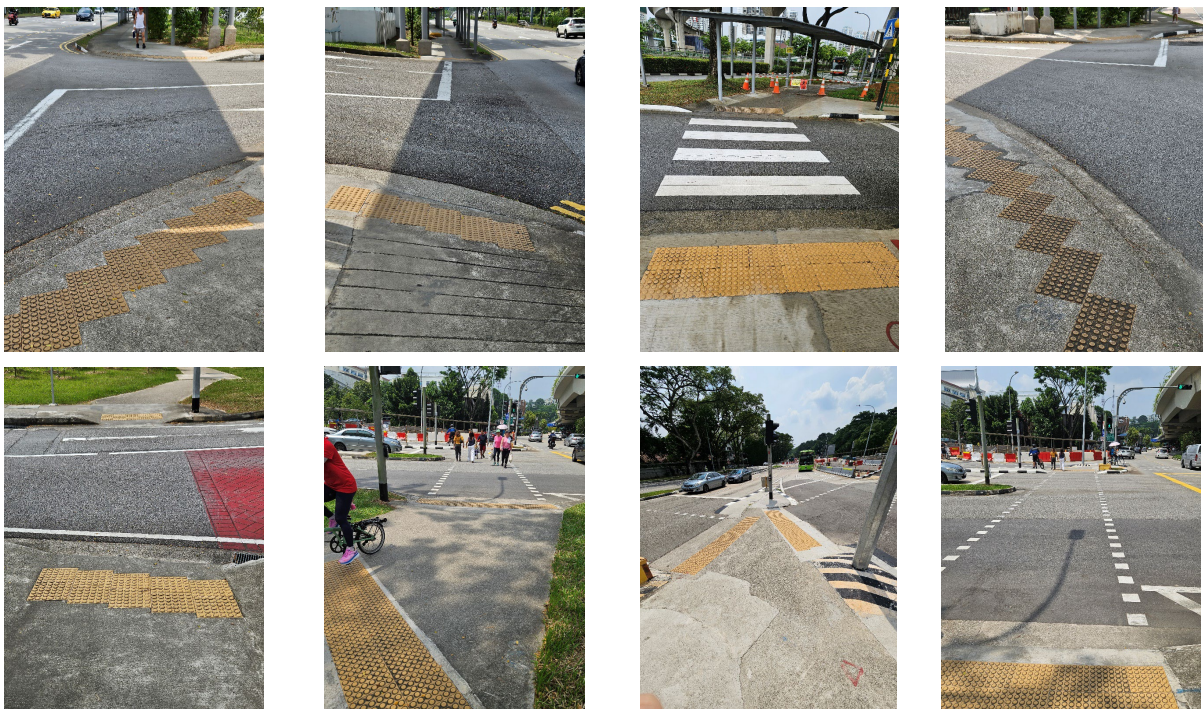
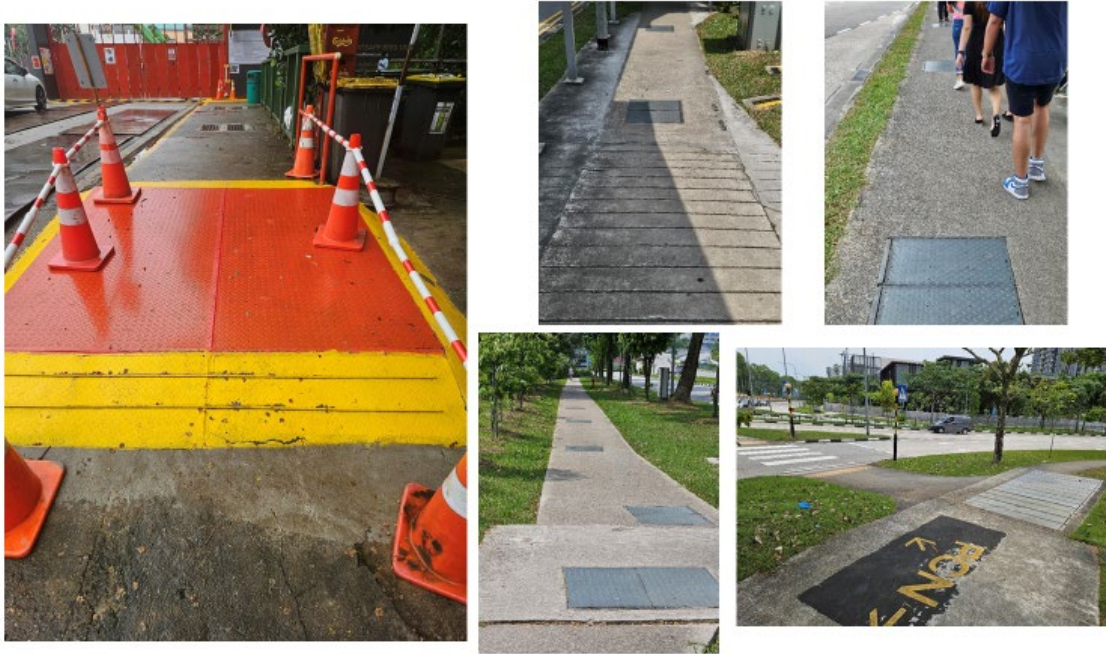
Figure 1 Some common coatings and features such as tactile and steel covering on pavements

Slips and falls are a leading cause of injuries globally and its prevention remains a pressing public safety and health challenge. While studies on hazards and risk control measures of slips and falls due to environmental and human factors have been widely conducted [1], little has been reported on the risk for pedestrians when stepping over coatings and features such as tactile, manhole covers, etc. (Figure 1) during wet days.

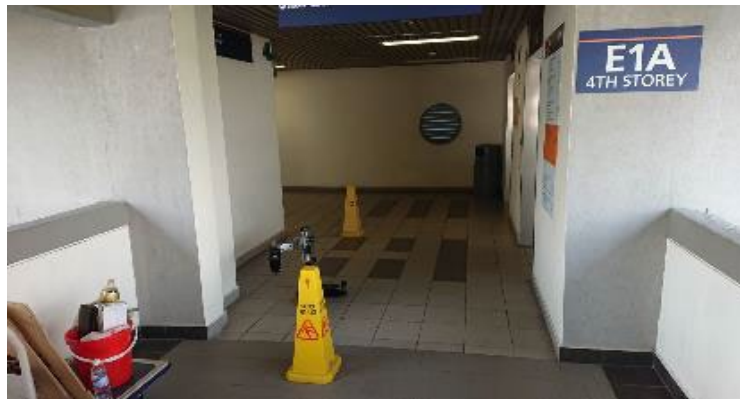
Case 1 – Bridge pathway – Ceramic Tile

Condition	C°	Travel (mm)	1X	1	2	3	4	BPN Average
As Is	30.5	125	58	58	57	58	58	58
Dry (Clean)	30.7	125	50	50	50	50	50	50
ASTM E303	29.8	125	28	27	26	25	25	26
Flow	29.6	125	26	24	23	23	23	23

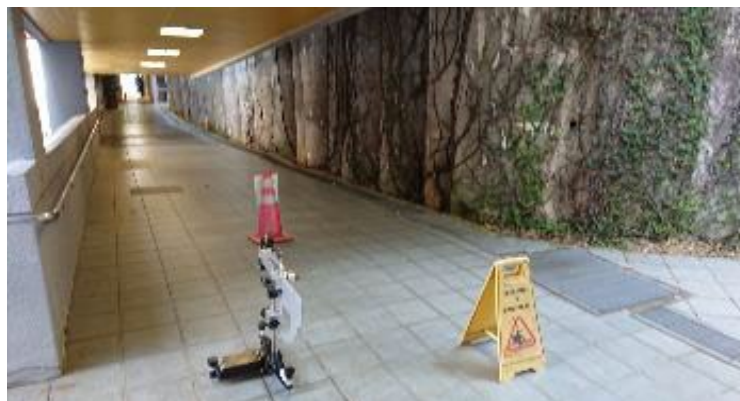
Case 2 – Link pathway – Ceramic Tile

Condition	C°	Travel (mm)	1X	1	2	3	4	BPN Average
As Is	32.4	127	52	55	53	58	58	56
Dry (Clean)	32.3	127	57	53	55	57	57	56
ASTM E303	31.6	127	32	33	31	31	31	32
Flow	30.5	127	30	28	28	25	28	27

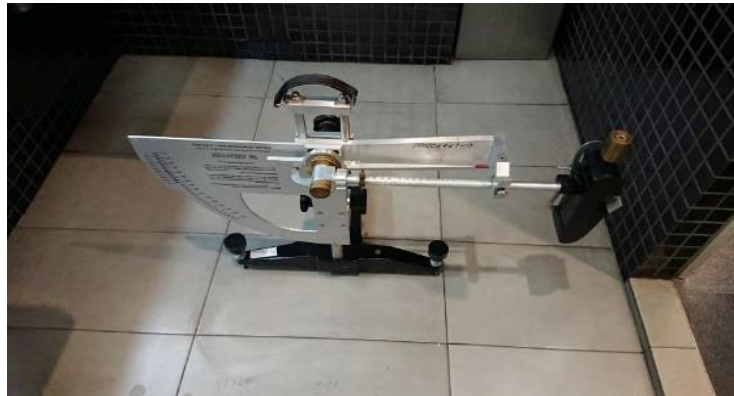
Case 3 – Washroom – Ceramic Tile

Condition	C°	Travel (mm)	1X	1	2	3	4	BPN Average
As Is	29.7	127	71	73	76	77	79	76
Dry (Clean)	29.7	127	72	72	77	78	81	77
ASTM E303	29.5	127	29	27	26	24	26	26
Flow	29	127	22	24	24	26	25	25

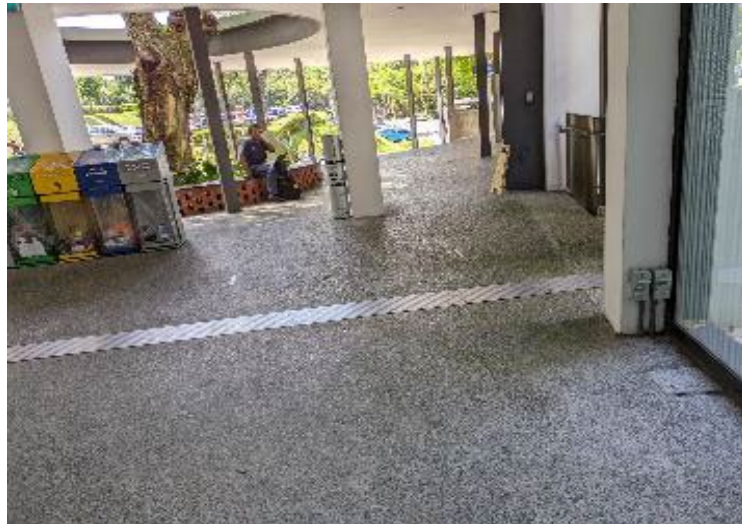
Case 5 – Lobby – Pebble

Condition	C°	Travel (mm)	1X	1	2	3	4	BPN Average
As Is	27.7	127	72	77	77	85	76	79
Dry (Clean)	27.3	127	80	83	78	76	80	79
ASTM E303	27.2	127	39	36	37	37	39	37
Flow	27.2	127	37	35	34	33	32	34

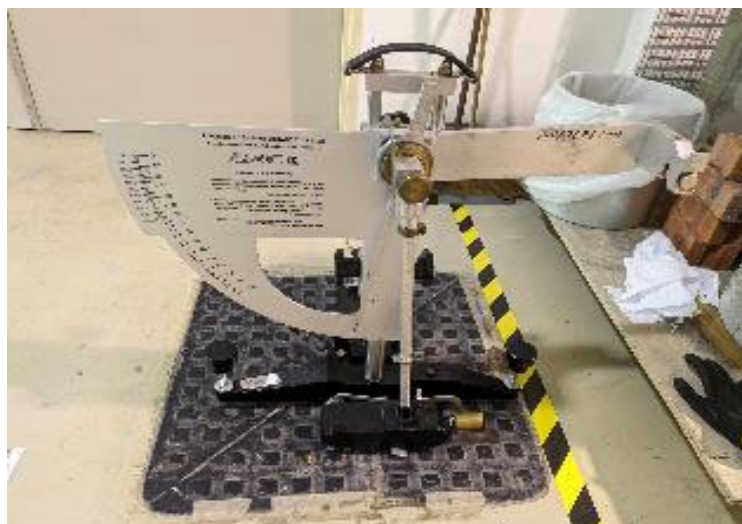
Case 6 – Outdoor – Stainless Steel Manhole Cover

Condition	C°	Travel (mm)	1X	1	2	3	4	BPN Average
As Is	27.5	124	51	54	54	56	55	55
Dry (Clean)	27.1	124	71	71	71	75	75	73
ASTM E303	27.3	124	32	26	30	30	33	30
Flow	26.9	124	36	35	32	34	36	34

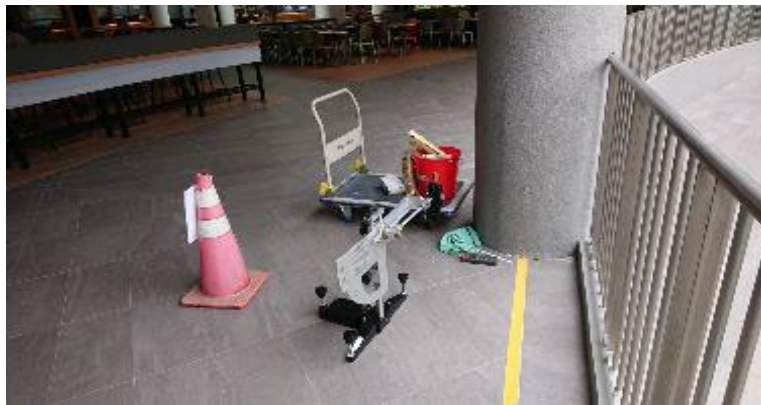
Case 7 – Canteen– Ceramic Tile

Condition	C°	Travel (mm)	1X	1	2	3	4	BPN Average
As Is	28.6	127	64	73	64	68	74	70
Dry (Clean)	28.4	127	65	68	70	68	68	69
ASTM E303	28.1	127	23	23	22	20	21	22
Flow	28	127	22	21	22	21	22	22

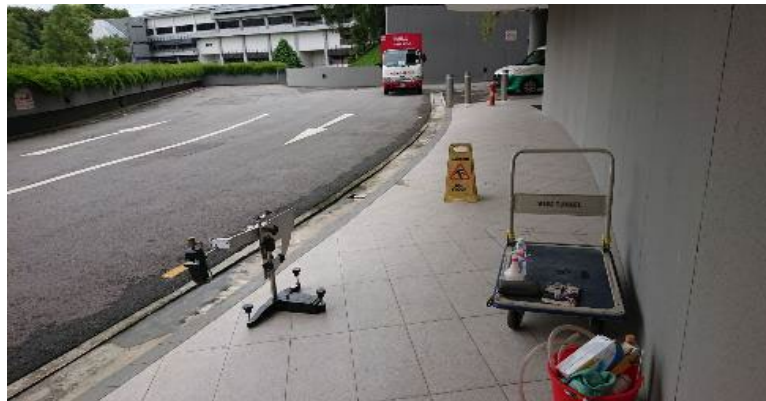
Case 8 – Pathway – Ceramic Tile

Condition	C°	Travel (mm)	1X	1	2	3	4	BPN Average
As Is	30	125	70	69	63	66	62	65
Dry (Clean)	30.9	125	59	56	65	71	68	65
ASTM E303	30.5	125	26	20	20	21	23	21
Flow	30	125	21	22	20	21	22	21

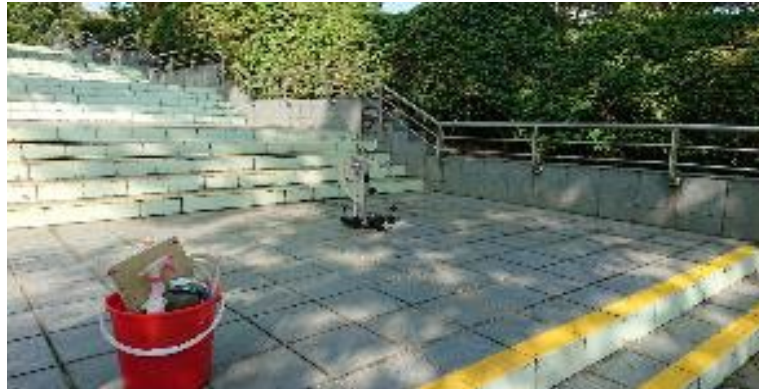
Case 9 – Outdoor – Ceramic Tile

Condition	C°	Travel (mm)	1X	1	2	3	4	BPN Average
As Is	30.7	124	58	54	60	60	61	59
Dry (Clean)	28.3	124	58	71	68	60	67	67
ASTM E303	-	124	31	28	27	27	26	27
Flow	-	124	24	25	27	26	24	26

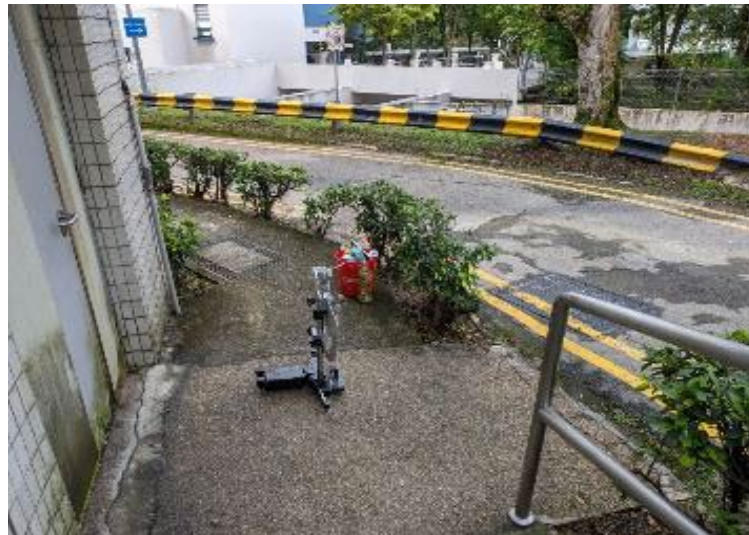
Case 11 – Outdoor pavement– Pebble

Condition	C°	Travel (mm)	1X	1	2	3	4	BPN Average
As Is	26.3	127	70	75	75	75	80	76
Dry (Clean)	26.2	127	81	81	80	83	82	82
ASTM E303	26.2	127	31	29	30	30	30	30
Flow	26.1	127	27	27	28	28	29	28

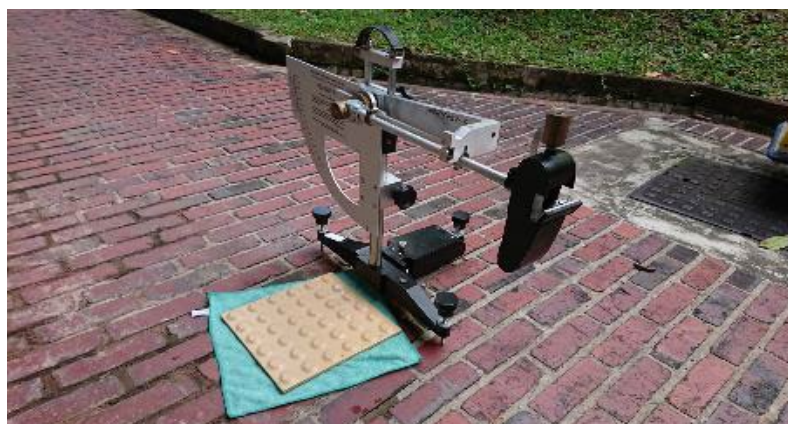
Case 12 – Outdoor – Ceramic Tactile

Condition	C°	Travel (mm)	1X	1	2	3	4	BPN Average
As Is	27.7	127	40	69	70	74	76	72
Dry (Clean)	28.2	127	65	64	80	84	78	77
ASTM E303	28.1	127	33	40	36	23	31	33
Flow	26.6	127	36	30	29	33	28	30

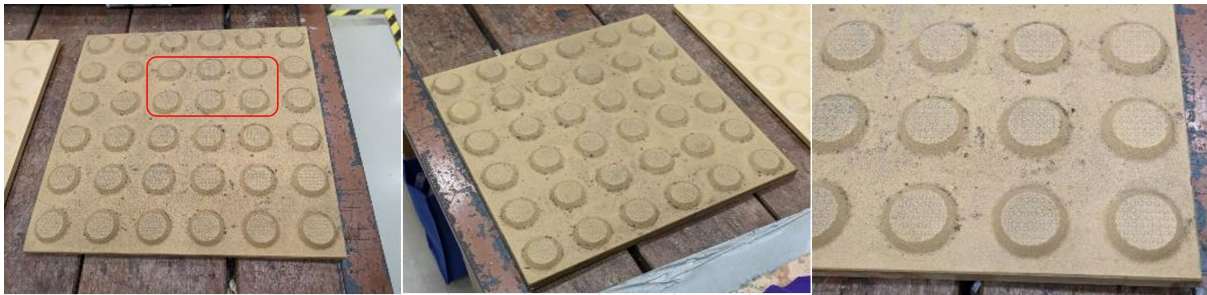
Test – 1

Condition	C°	Travel (mm)	1X	1	2	3	4	BPN Average
As Is	27.6	126	54	53	53	50	48	51
Dry (Clean)	NA	NA	NA	NA	NA	NA	NA	NA
ASTM E303	27	126	32	32	30	30	31	31
Flow	26.6	126	26	31	31	28	24	29

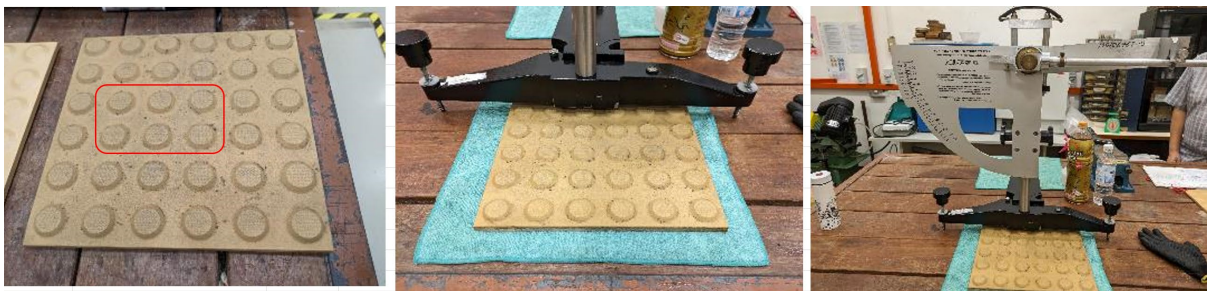
Test – 2

Condition	C°	Travel (mm)	1X	1	2	3	4	BPN Average
As Is	28.2	126	60	49	58	55	50	53
Dry (Clean)	NA	NA	NA	NA	NA	NA	NA	NA
ASTM E303	27.7	126	37	38	37	34	34	36
Flow	27.4	126	35	35	33	30	33	33

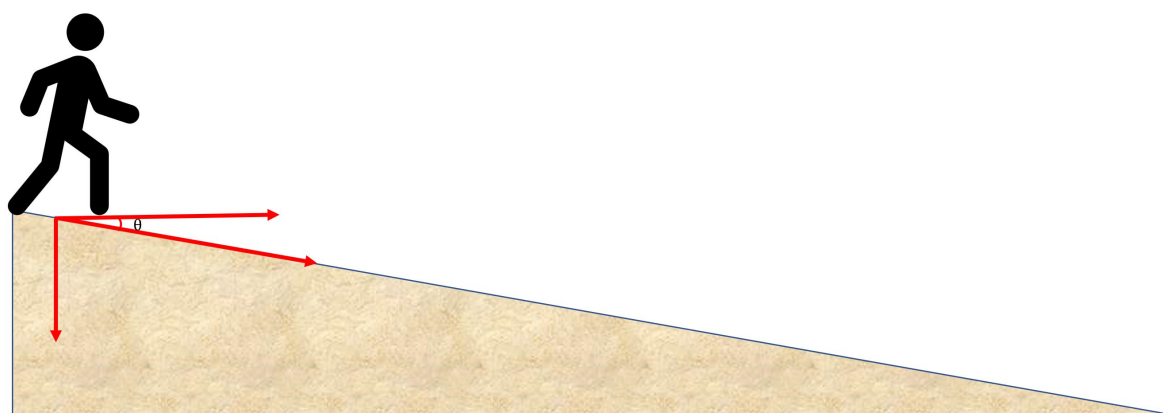
The situation can be further exacerbated when a pedestrian is using a slope, in which case the force on the slope can be computed based on the forward force and the weight of the pedestrian (Figure 3).

Figure 3 Higher slip resistance required on a slope

A higher 'Pendulum Test Value' (PTV) to prevent slips on slopes is required. Health and Safety Executive (HSE) recommends that for a horizontal floor where a Pendulum Test Value of 36 PTV on a WET or CONTAMINATED floor is required to ensure a 'Low Slip Potential', for every one degree of slope, the PTV value shall be increased by 1.75 PTV. It is suggested to use approximately 2 PTV per degree to allow for tolerancing and floor wear.
