# 1. Introduction

Tempered glass shower screens were introduced in Housing & Development Board (HDB) premium flats in 1999. Since then, 18,000 premium flats has been installed with tempered shower screen of which 14,000 flats completed installation and 4,000 flats are under construction.

# 5. Tempered Glass Breakage Investigation

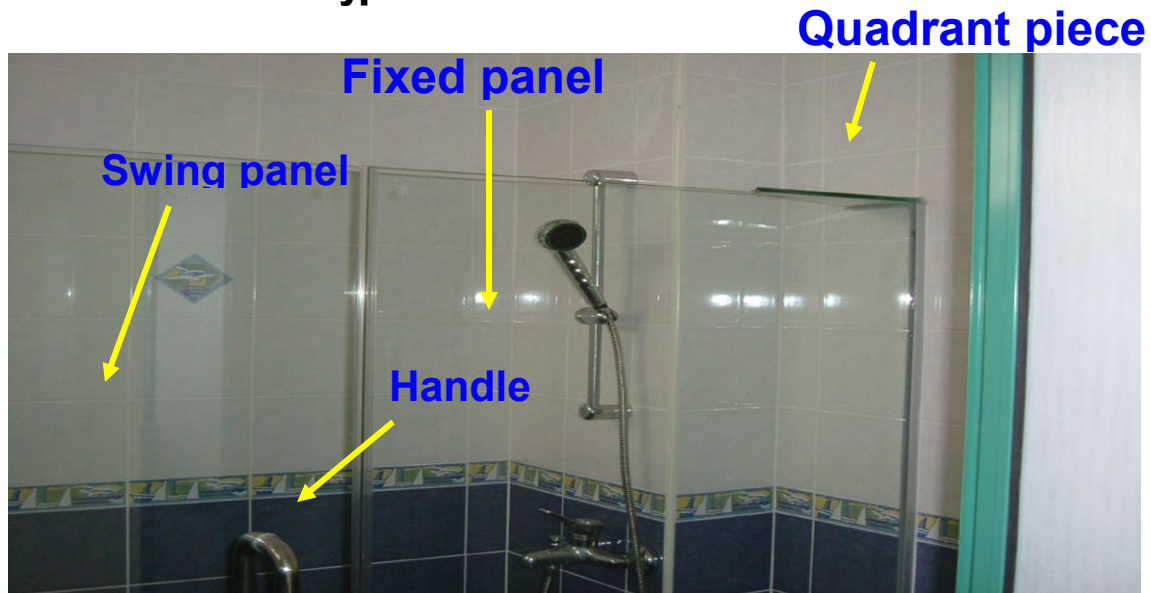
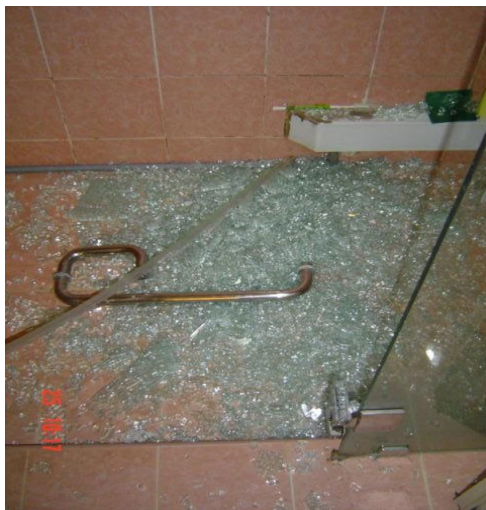
## Typical Master Toilet Shower Screen

Inspection was conducted on the same day and due to the urgency of the case, a personal from Building Technology Department was called for joint inspection. It was noted that, the swing panel of 8mm thick frameless glass was totally shattered and the fixed panel was intact. The fixed panel was intact, as it may due to the installation of quadrant piece between two fixed panels which make it more stable.
